I-405, Tukwila to I-90 Vicinity Express Toll Lanes Project (MP 0.0 to 11.9)

Attachment E: Cultural Resources Survey

**Cultural Resources Survey for the Washington State
Department of Transportation's I-405 Renton to Bellevue
Improvement Project: SR 169 to I-90,
King County, Washington**

Short Report DOT2016-06
Archaeological and Historical Services
Eastern Washington University

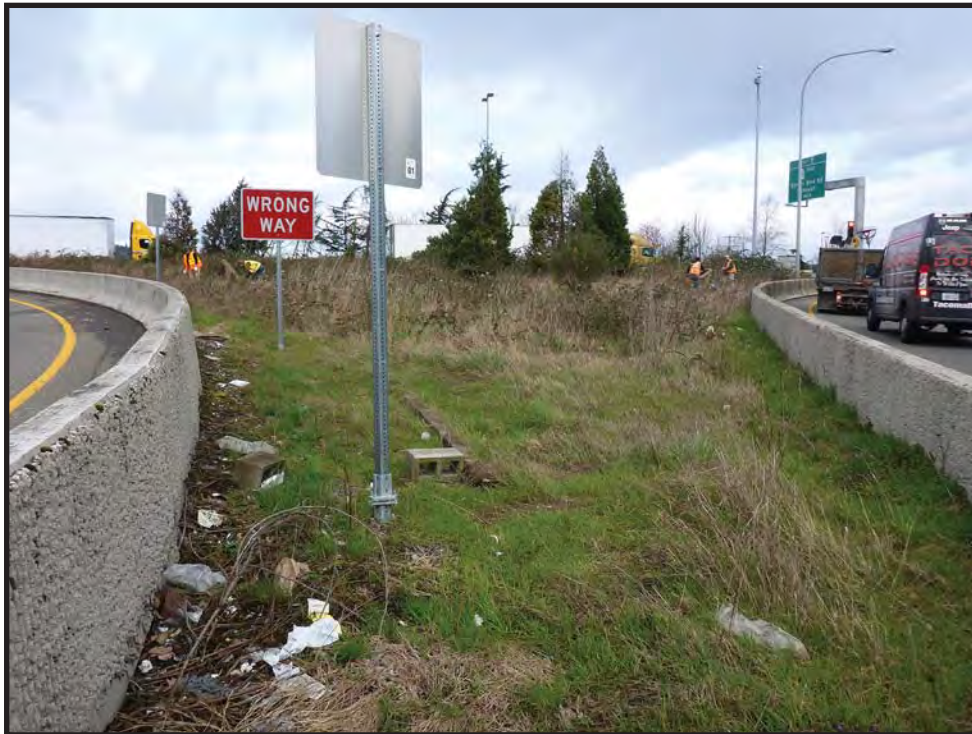
Figure 2. Crew excavating shovel tests in Zone 1, an island of compacted fill between the northbound I-405 on-ramp from SR-169 Maple Valley Highway and the I-405 corridor. View to the west.

Zone 1 survey and shovel testing identified no evidence of prehistoric or historic cultural materials or features. No evidence of intact sediments was identified in Zone 1. While it is possible that intact sediments are present below the fill, surface grading likely conducted prior to transportation infrastructure construction would have greatly limited the potential for intact archaeological deposits within Zone 1. Archaeological site potential is low within Zone 1 and no further cultural resources work is recommended.

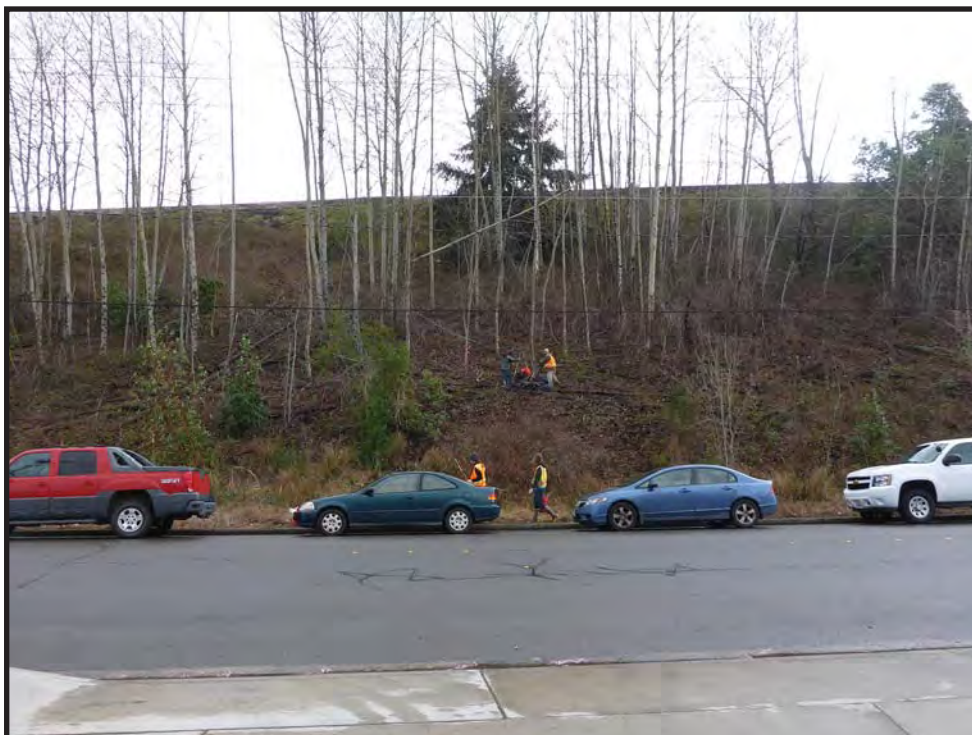
Figure 3. Crew excavating ST 16 in Zone 5. Shovel tests were excavated on the fill covered slope between the Houser Way bypass and I-405 southbound lanes. View to the east.

This fill zone is largely the paved lanes of I-405 between the Sunset Highway onramp to the south and the NE Park Drive to the north (Figure 3). Investigated with this zone is the portion of North 8th Street in Renton and an adjacent parking lot. The only unpaved portion of Zone 5 is the western boundary, which occupies a fill slope between the Houser Way bypass and I-405 southbound lanes. The eastern edge of the historic Black River parallels the length of this zone. Wetlands associated with the current channel of Johns Creek are located at the base of the slope near the intersection of Houser Way bypass and NE Park Drive. Deep augering in advance of the construction of the Lowe's Home Improvement Store in Renton, ca. 600 feet west of the project resource evaluation area, identified sediments interpreted as ancient wetlands and shallow near-shore deposits related to the ancestral Black River below a cap of fill materials (Hodges 2007).

Aside from Northern Pacific Lake Washington Belt Line tracks, which cross N 8th street within Zone 5, survey and shovel testing identified no evidence of prehistoric or historic cultural materials or features. While evidence of intact Pleistocene sediments is present in Zone 5, shovel test results demonstrate that archaeological site potential is low. No further cultural resources work is recommended within Zone 5.

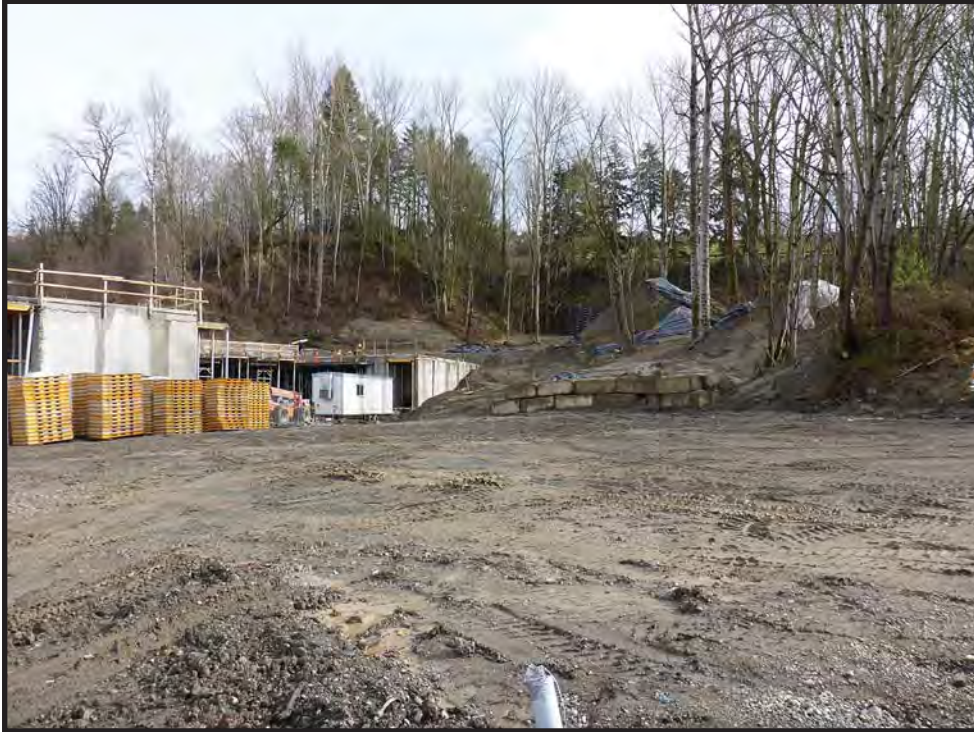
Figure 4. The area adjacent to Zone 18, showing ongoing commercial or residential construction to the east of Lake Washington Boulevard near the entrance to Gene Coulon Memorial Park. View to the east.

Aside from tracks of the Northern Pacific Lake Washington Belt Line, which cross Lake Washington Boulevard near the south end of Zone 18, survey and shovel testing in Zone 18 identified no evidence of prehistoric or historic cultural materials or features. See the Built Environment Survey section below for a discussion of the Northern Pacific Lake Washington Belt Line. While evidence of intact Pleistocene sediments is present in Zone 18, shovel test results demonstrate that archaeological site potential is low. No further cultural resources work is recommended in Zone 18.

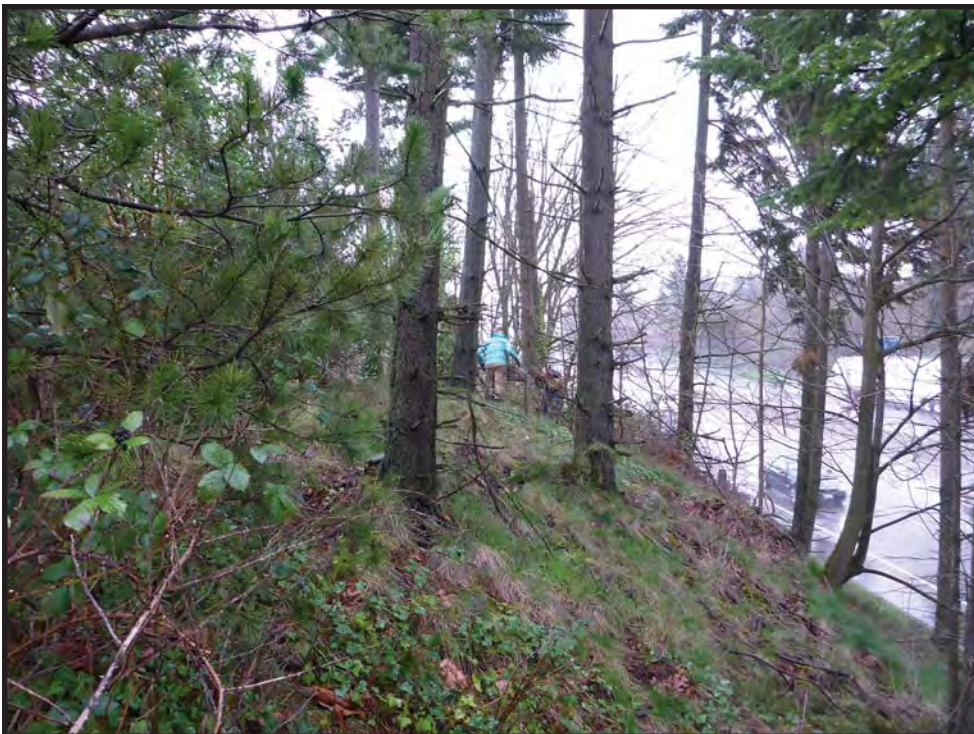
Figure 5. Crew excavating ST 19 in Zone 18. Shovel tests were excavated to the west and above the cut for the southbound lanes of I-405. View to the northeast.

This fill zone is largely comprised of the paved lanes of I-405 north from Park Drive to Project MP 6.00. Included with the zone is an area to the east of Lake Washington Boulevard near the entrance to Gene Coulon Memorial Park (Figure 4). Ten shovel tests (STs 19, 22, 23, 25, 26, 28, 86, 88, 90, and 103) were excavated to the west and above the cut for the southbound lanes of I-405 (Figure 5) (see Figures B.6 and B.7). Native sediments, uncapped by fill, were identified in six of the STs. Native sediments were gravelly loamy sands, and mapped as glacial sandy outwash which formed after the retreat of glacial ice during the late Pleistocene (Soil Survey Staff 2015).

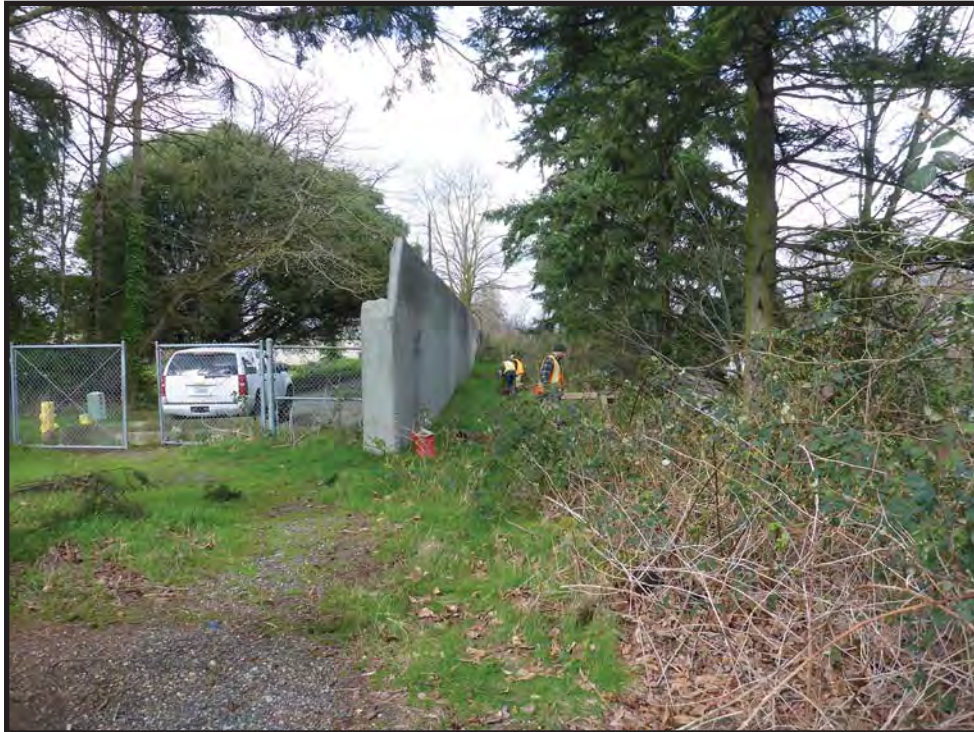
Figure 6. Crew excavating in Zone 21. Native sediments were disturbed to a depth greater than a meter in the tested portion of Zone 21. View to the north.

This fill zone comprises an area of earth mounds, presumably spoils from noise wall construction. The zone is bound by NE 30th Street on the north, I-405 southbound traffic on the east, Project MP 6.00 on the south (approximately) and a tall concrete noise wall to the west (Figure 6). Native sediments, uncapped by fill, were identified in all four shovel tests (STs 82, 84, 99, and 101) excavated in Zone 21 (see Figure B.7). However, the native sediments were disturbed to a depth greater than a meter, based on the presence of modern debris throughout screened sediments. Native sediments are mapped as glacial sandy outwash, gravelly loamy sands formed after the retreat of glacial ice during the late Pleistocene (Soil Science Survey 2016).

Survey and shovel testing in Zone 21 identified no evidence of prehistoric or historic cultural materials or features. While evidence of Pleistocene sediments is present in the sampled portion of Zone 21, disturbance related to transportation infrastructure construction has greatly limited the potential for intact archaeological deposits. Survey and shovel test results demonstrate that archaeological site potential within Zone 21 is low and no further cultural resources work is recommended.

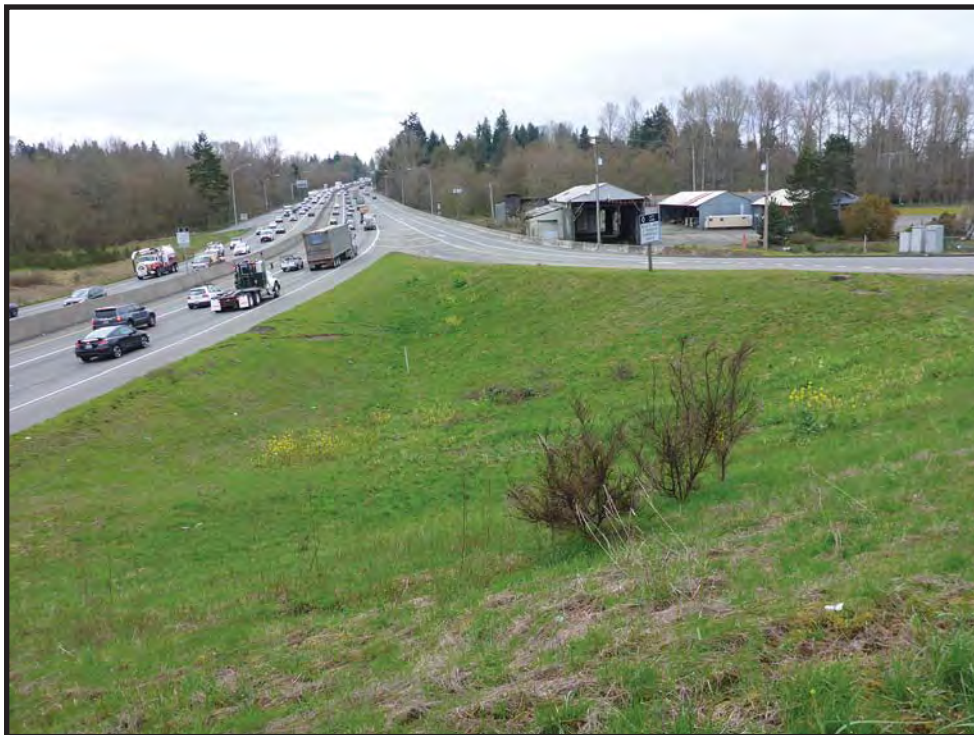
Figure 7. Overview of I-405 from the NE 44th Street interchange, near the north end of Zone 25. Shovel test 76 was excavated in the traffic island at the southwest corner of the NE 44th Street interchange, shown in this photograph to the south.

This fill zone is largely the paved lanes of I-405 extending north from NE 30th Street, to NE 44th Street, incorporating the edges of four traffic islands near the NE 44th Street interchange (Figure 7). A single shovel test (ST 76) was excavated in the traffic island at the southwest corner of the NE 44th Street interchange (see Figure B.10). Sediment compaction and groundwater infill halted excavation before the base of compacted fill was reached in the single shovel test. Native sediments, mapped as Holocene alluvial sandy loam likely associated with Gypsy Creek to the north, were not encountered in Zone 25.

Survey and shovel testing in Zone 25 identified no evidence of prehistoric or historic cultural materials or features. No evidence of intact sediments was identified in Zone 25. While it is possible that intact sediments are present below the fill, surface grading related to transportation infrastructure construction has greatly limited the potential for intact archaeological deposits within Zone 25. Archaeological site potential is low within Zone 25 and no further cultural resources work is recommended.

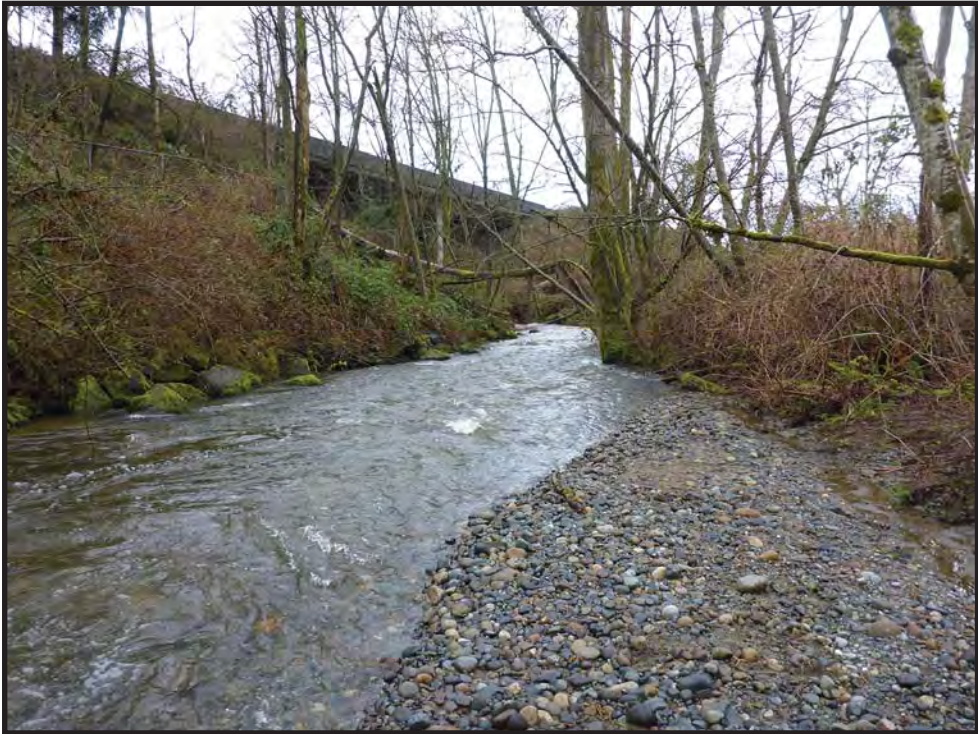
Figure 8. May Creek at the south end of Zone 29, located east of I-405, is shown in this photograph to the northwest.

Survey and shovel testing in Zone 29 identified no evidence of prehistoric or historic cultural materials or features. While evidence of intact Holocene sediments is present in Zone 29, shovel test results demonstrate that archaeological site potential is low. No further cultural resources work is recommended in Zone 29.

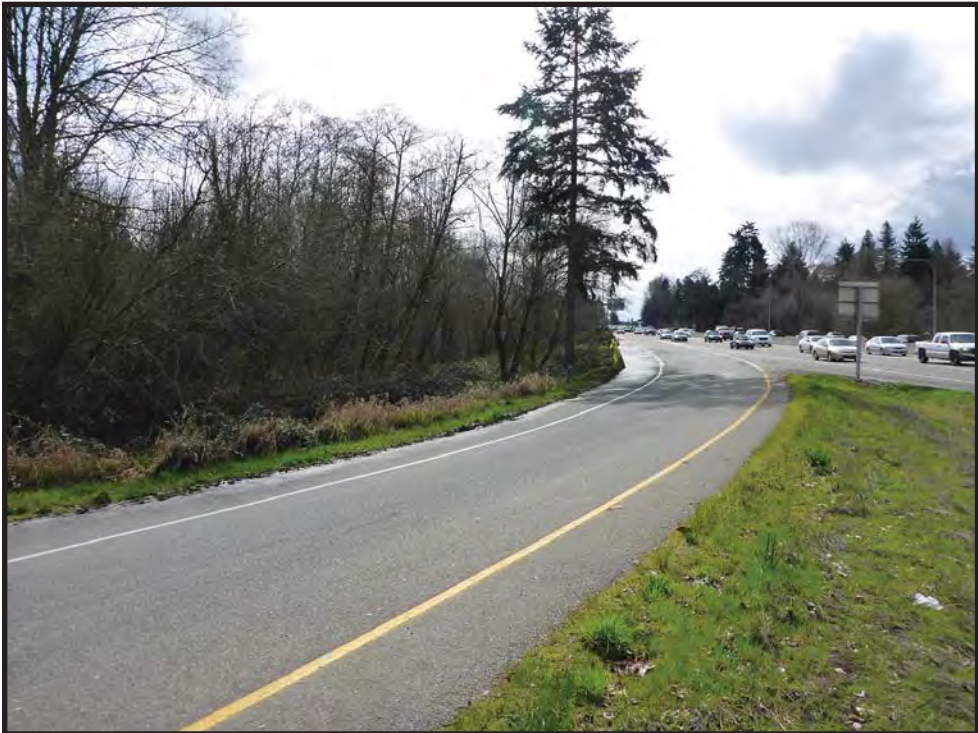
Figure 9. The wetland at the north end of Zone 29, east of the northbound I-405 off-ramp at NE 44th Street, is shown in this photograph to the south.

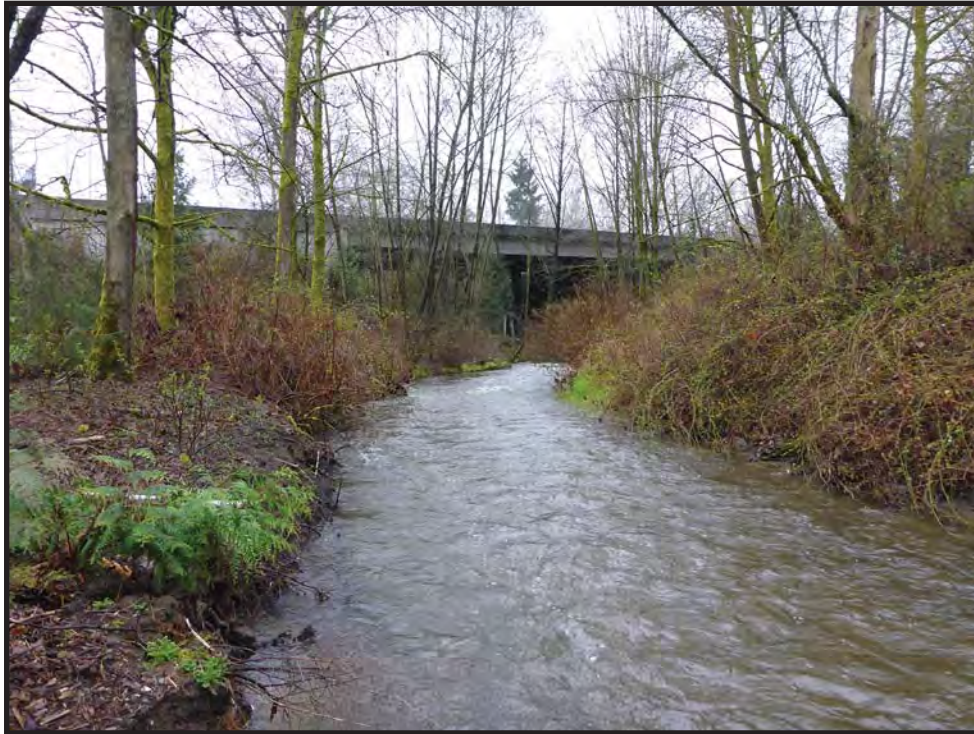
Figure 10. Zone 30, which includes May Creek to the west of I-405, is shown in this photograph to the southeast.

This restricted zone is the May Creek crossing on the west side of I-405 (Figure 10). This zone has been recently landscaped as a park with native plantings and unpaved trails (McAskill Park). Native sediments, Holocene alluvial sandy loam associated with May Creek, were identified in all eight shovel tests (STs 33, 35, 36, 39, 42, 164, 173, and 175) excavated in or adjacent to Zone 30 (see Figure B.10).

Survey and shovel testing in Zone 30 identified no evidence of prehistoric or historic cultural materials or features. While evidence of intact Holocene sediments is present in Zone 30, shovel test results demonstrate that archaeological site potential is low. No further cultural resources work is recommended in Zone 30.

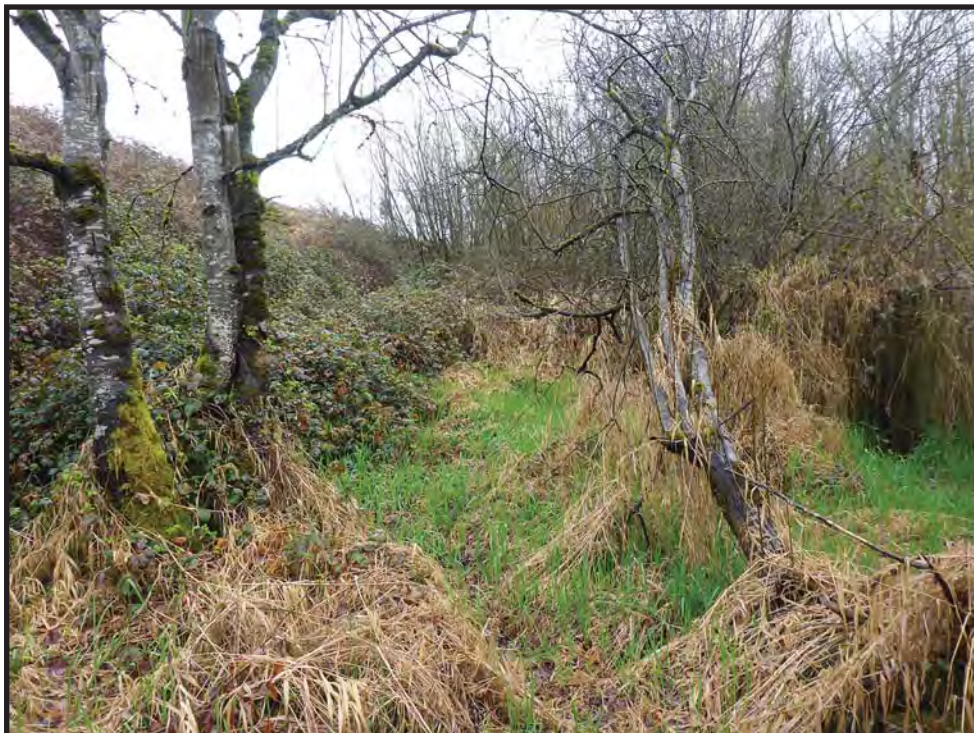
Figure 11. Zone 31, a narrow wedge of road fill adjacent to the elevated I-405 southbound lanes southwest of the NE 44th Street interchange, is shown in this photograph to the south.

Survey and shovel testing in Zone 31 identified no evidence of prehistoric or historic cultural materials or features. While evidence of intact Holocene sediments is present in Zone 31, shovel test results demonstrate that archaeological site potential is low. No further cultural resources work is recommended in Zone 31.

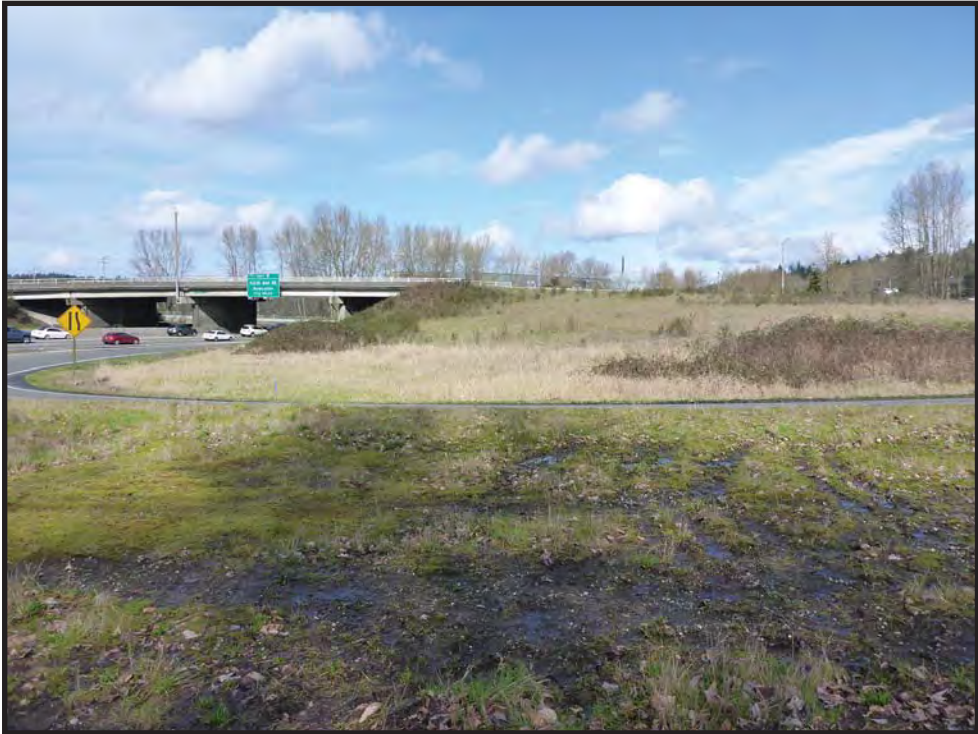
Figure 12. Zones 33 and 34, two traffic islands in the southeast corner of the NE 44th Street interchange are shown in this photograph to the north. Zone 33 is in the foreground and Zone 34 is in the background.

Survey and shovel testing in Zone 33 identified no evidence of prehistoric or historic cultural materials or features. No evidence of intact sediments was identified in Zone 33. While it is possible that intact sediments are present below the fill, transportation infrastructure construction-related activities have greatly limited potential for intact archaeological deposits in Zone 33. Archaeological site potential is low in Zone 33 and no further cultural resources work is recommended.

Archaeological site potential is low in Zone 34 and no further cultural resources work is recommended.

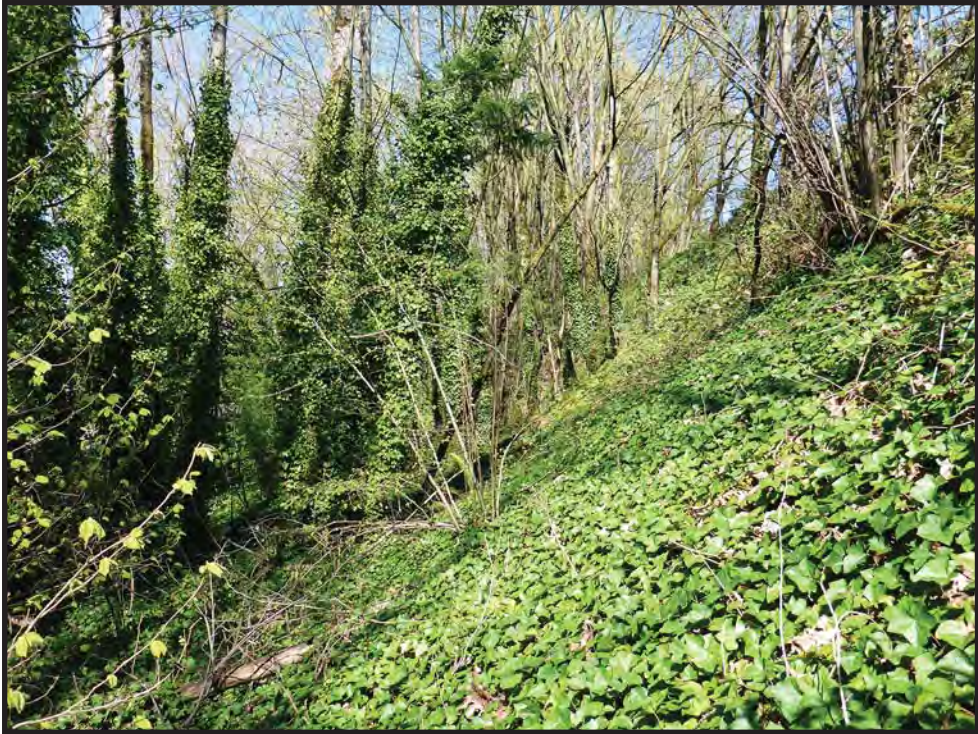
Figure 13. The steeply sloping road fill prism below (west of) I-405 southbound lanes in Zone 35 is shown in this photograph to the north.

Features of the Northern Pacific Lake Washington Belt Line, including tracks and a trestle over Ripley Lane near the south end and tracks adjacent to Pleasure Point Lane SE near the north end, are located within Zone 35. Survey and shovel testing within Zone 35 identified no evidence of prehistoric or historic cultural materials or features. While evidence of intact Pleistocene sediments is present in portions of Zone 35, shovel test results demonstrate that archaeological site potential is low. No further cultural resources work is recommended in Zone 35.

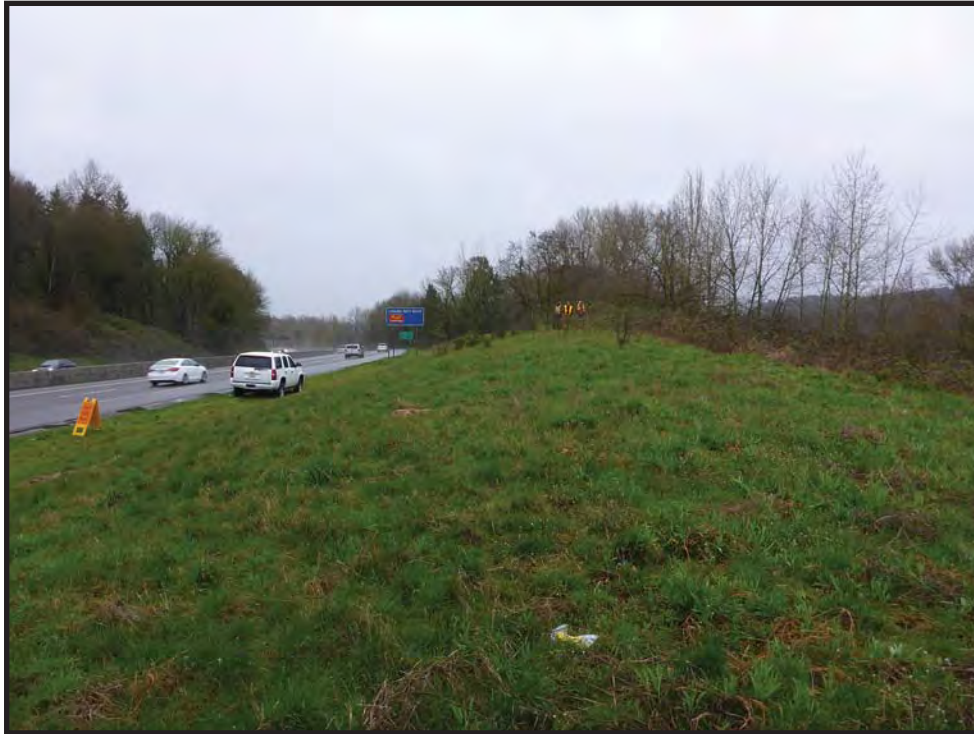
Figure 14. A large fill berm west of I-405 near MP 8.85 in Zone 35 is shown in this photograph to the southwest.

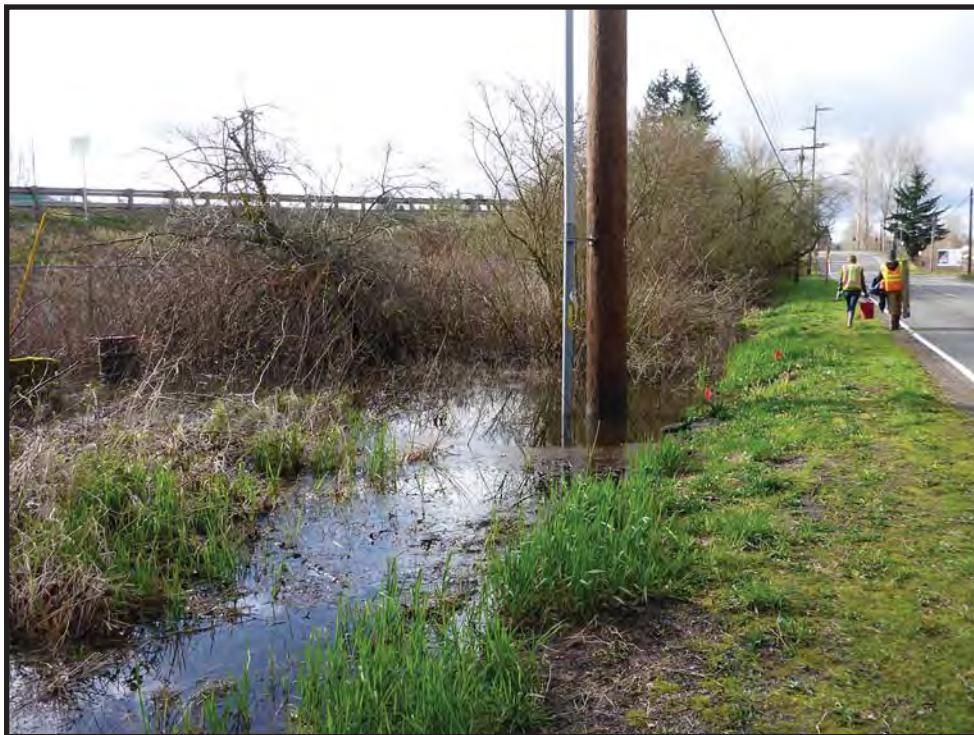
Figure 15. A marshy area near the south end of Zone 35, to the east of Seahawks Way, is shown in this photograph to the south.

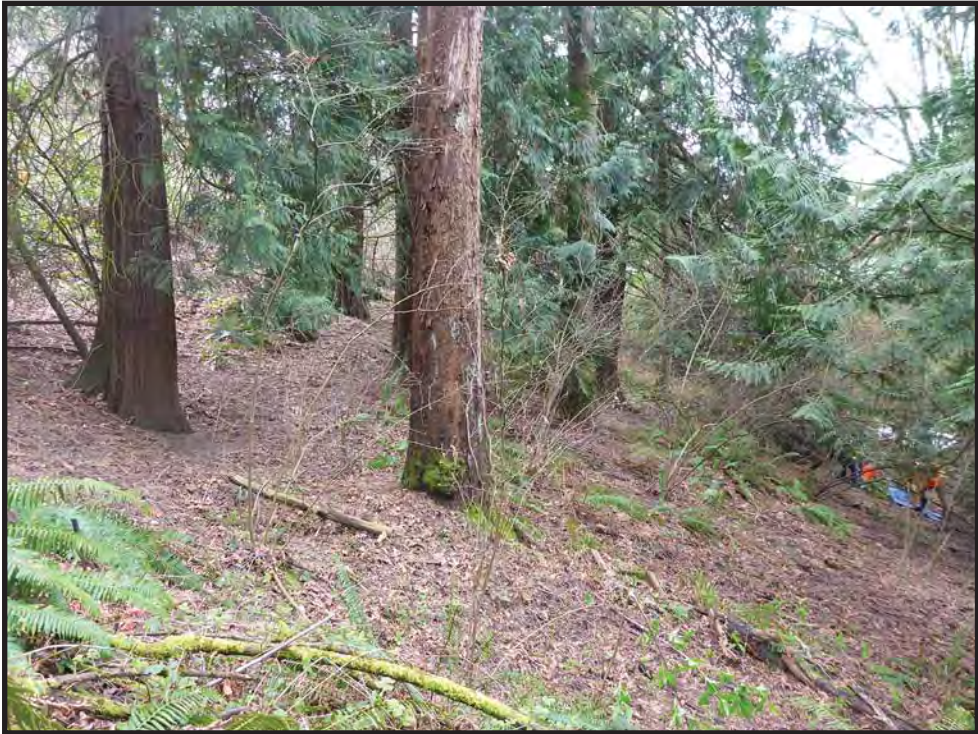
Figure 16. A densely vegetated area to the east of the bike path and Lake Washington Boulevard near the north end of Zone 35 is shown in this photograph to the south.

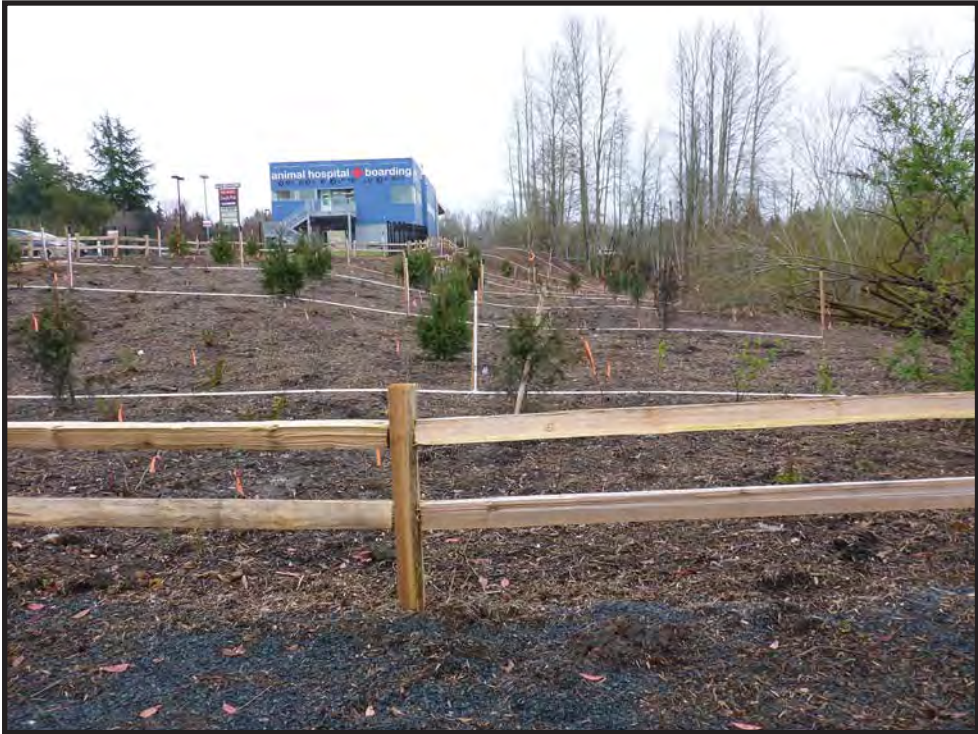
Figure 17. Recent landscaping including native plantings within Zone 36, located in the northeast corner of the of the NE 44th Street interchange. The modern Gypsy Creek channel is at the right in this photograph to the south.

Survey and shovel testing in Zone 36 identified no evidence of prehistoric or historic cultural materials or features. While evidence of intact Pleistocene sediments is present in portions of Zone 36, shovel test results demonstrate that archaeological site potential is low. No further cultural resources work is recommended in Zone 36.

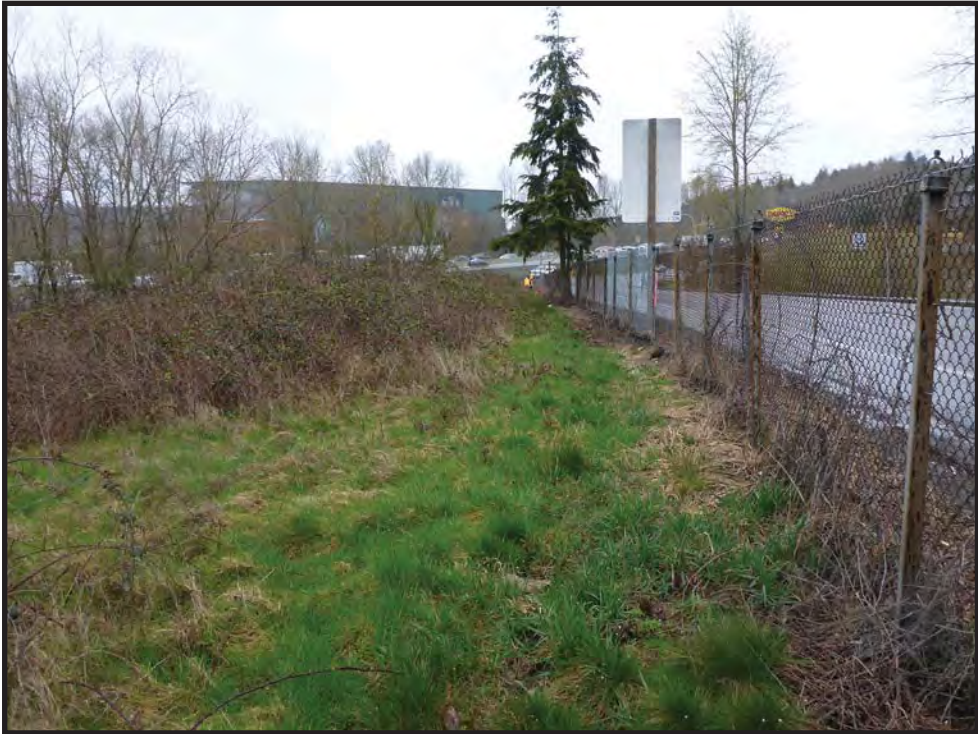
Figure 18. Crew excavating shovel tests on the eastern margin of a storm water retention pond located in Zone 37 is shown in this photograph to the north.

Survey and shovel testing in Zone 37 identified no evidence of prehistoric or historic cultural materials or features. No evidence of intact sediments was identified in Zone 37. While it is possible that intact sediments are present below the fill, transportation infrastructure construction-related activities have greatly limited the potential for intact archaeological deposits in Zone 37. Archaeological site potential is low in Zone 37 and no further cultural resources work is recommended.

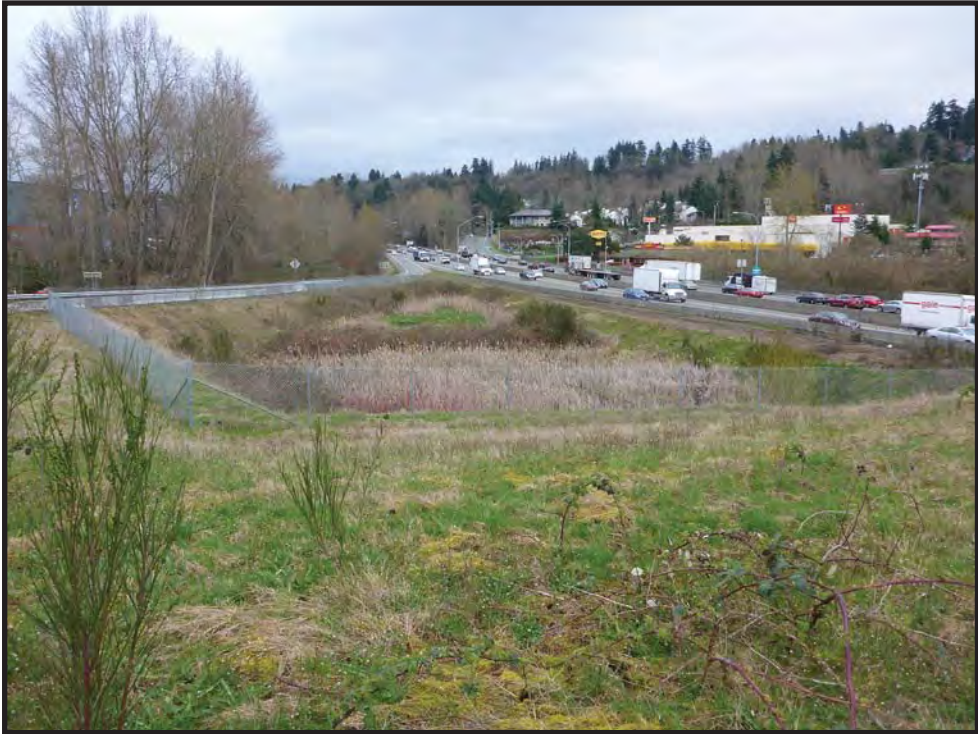
Figure 19. The storm water retention pond located in Zone 38 is shown in this photograph to the northeast.

Survey and shovel testing in Zone 38 identified no evidence of prehistoric or historic cultural materials or features. No evidence of intact sediments was identified in Zone 38. While it is possible that intact sediments are present below the fill, transportation infrastructure construction-related activities have greatly limited the potential for intact archaeological deposits in Zone 38. Archaeological site potential is low in Zone 38 and no further cultural resources work is recommended.

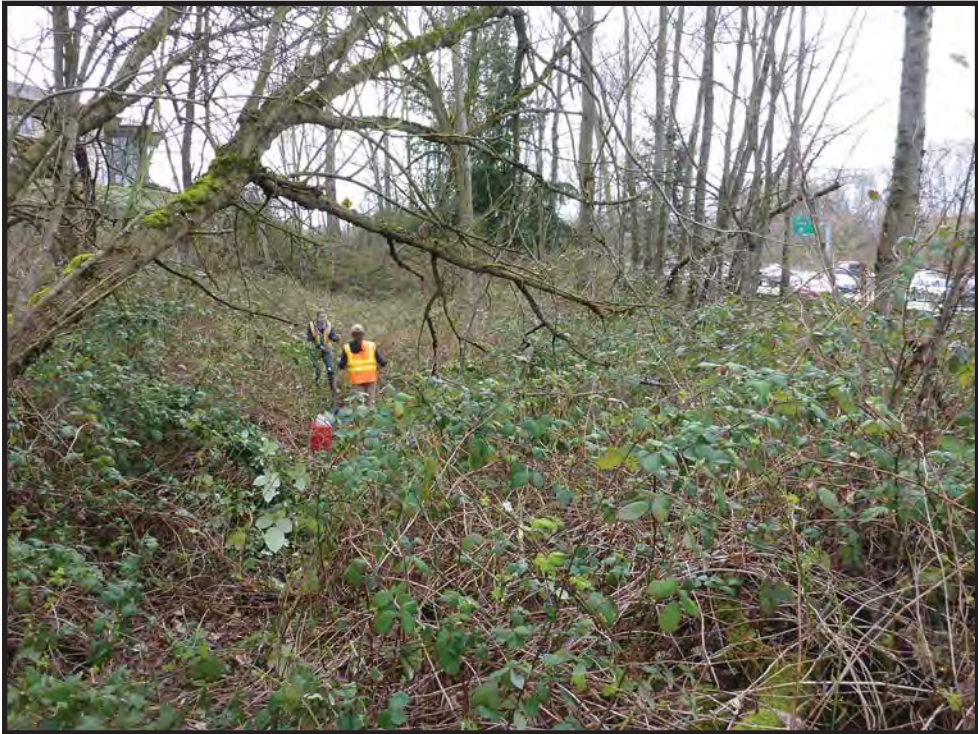
Figure 20. Densely vegetated Zone 40 is shown in this photograph to the south.

Survey and shovel testing in Zone 40 identified no evidence of prehistoric or historic cultural materials or features. While evidence of intact Pleistocene sediments is present below fill in portions of Zone 40, shovel test results demonstrate that archaeological site potential is low. No further cultural resources work is recommended in Zone 40.

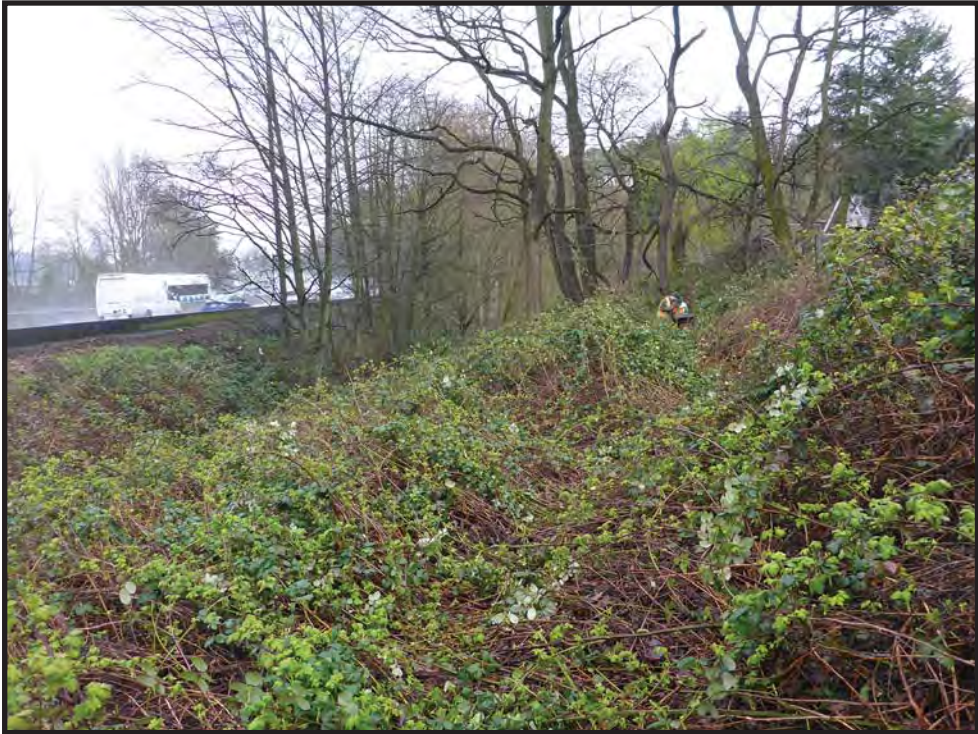
Figure 21. The densely vegetated slope in Zone 42 is shown in this photograph to the north.

Survey and shovel testing in Zone 42 identified no evidence of prehistoric or historic cultural materials or features. While evidence of intact Holocene sediments is present in Zone 42, shovel test results demonstrate that archaeological site potential is low. No further cultural resources work is recommended in Zone 42.

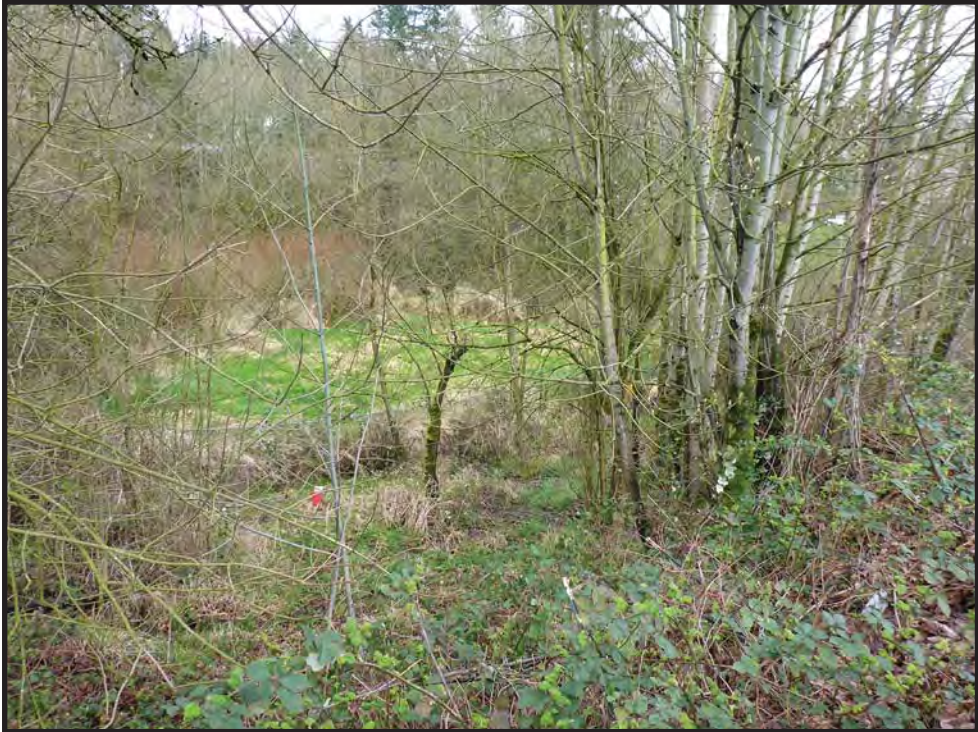
Figure 22. Marshy field fed by Unnamed Creek in Zone 43. View to the southeast.

Zone 43 survey and shovel testing identified no evidence of prehistoric or historic cultural materials or features. While evidence of intact Holocene sediments is present in Zone 43, shovel test results demonstrate that archaeological site potential is low. No further cultural resource work is recommended in Zone 43.

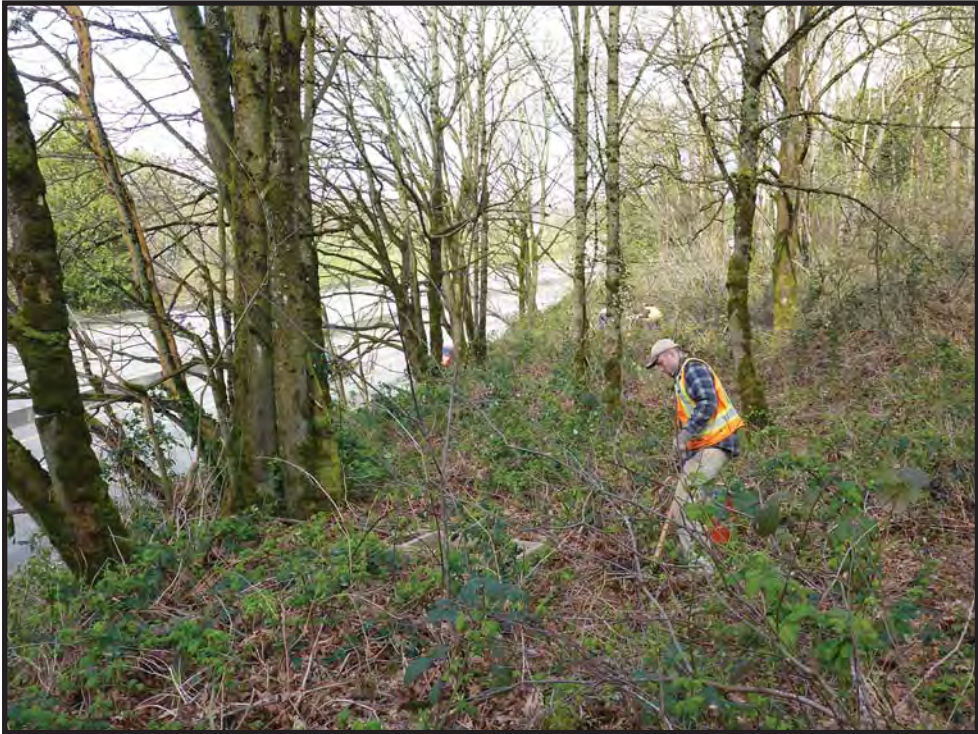
Figure 23. Crew excavating shovel tests in an undeveloped area crossed by Unnamed Creek in Zone 44a. View to the north.

Survey and shovel testing in Zone 44a identified no evidence of prehistoric or historic cultural materials or features. While evidence of intact Holocene sediments is present in Zone 44a, shovel test results demonstrate that archaeological site potential is low. No further cultural resources work is recommended in Zone 44a.

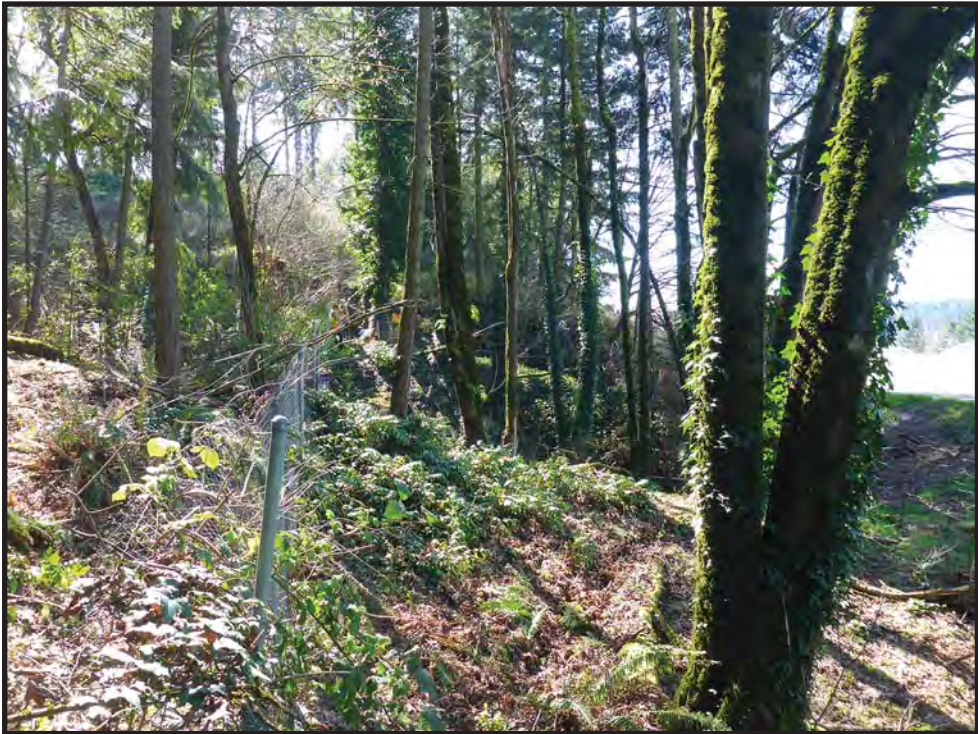
Figure 24. The east to west cuts on the sloping Zone 45 landform, visible in this photograph to the southwest, are likely ephemeral or former stream channels that were dry at the time of survey.

Survey and shovel testing in Zone 45 identified no evidence of prehistoric or historic cultural materials or features. While evidence of intact Holocene sediments is present in Zone 45, shovel test results demonstrate that archaeological site potential is low. No further cultural resource work is recommended in Zone 45.

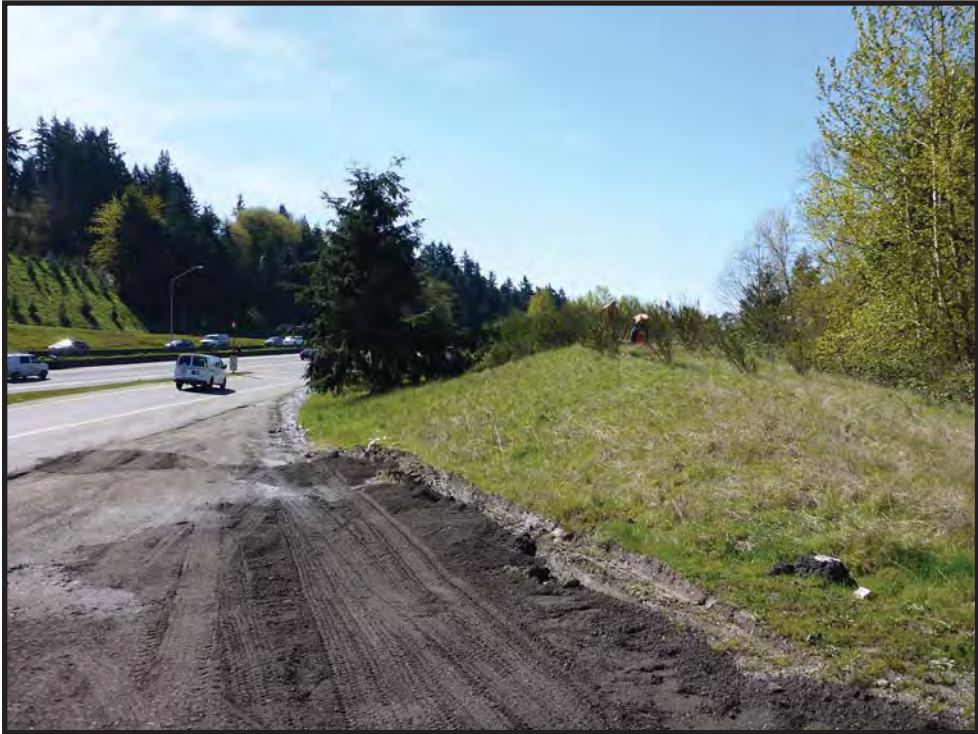
Figure 25. Zone 48, a linear earthen berm, is similar to the berm at the north end of Zone 35 (see Figure 14). View to the southwest.

Survey and shovel testing in Zone 48 identified no evidence of prehistoric or historic cultural materials or features. While it is possible that intact sediments are present below the fill, transportation infrastructure construction-related activities have likely greatly limited the potential for intact archaeological deposits in Zone 48. Archaeological site potential is low in Zone 48 and no further cultural resources work is recommended.

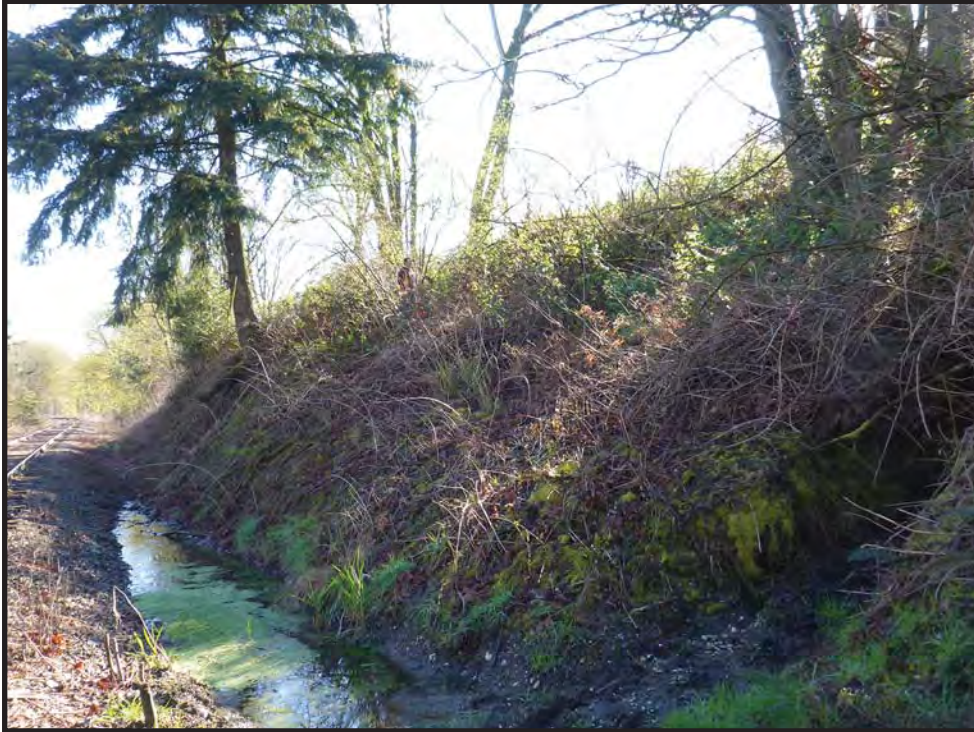
Figure 26. Portion of Zone 49 bordered on the west by the railroad grade. The crew is excavating ST 184 in this view to the northeast.
