I-405, Tukwila to I-90 Vicinity Express Toll Lanes Project (MP 0.0 to 11.9)

Attachment E: Cultural Resources Survey

**Cultural Resources Survey for the Washington State
Department of Transportation's I-405 Renton to Bellevue
Improvement Project: SR 169 to I-90,
King County, Washington**

Short Report DOT2016-06
Archaeological and Historical Services
Eastern Washington University

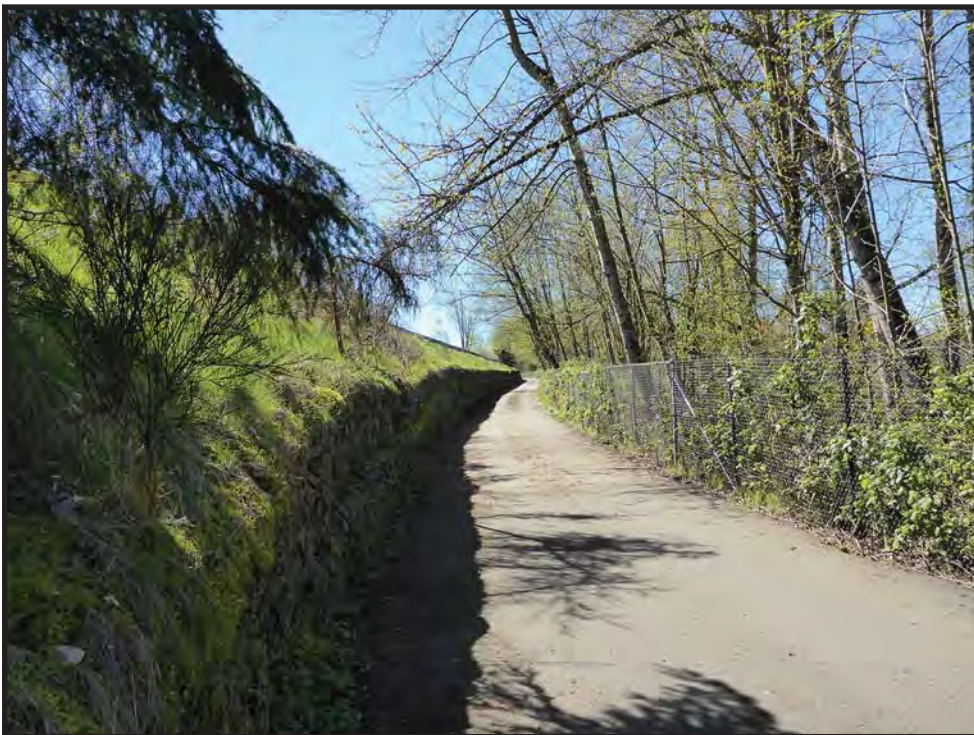
Figure 27. A paved bike path in northern Zone 49 (from the entrance of Newcastle Beach Park north to Coal Creek Parkway) is shown in this photograph to the south. Rock gabions support the fill slope below I-405.

related activities have greatly limited the potential for intact archaeological deposits in Zone 49. Archaeological site potential is low in Zone 49 and no further cultural resources work is recommended.

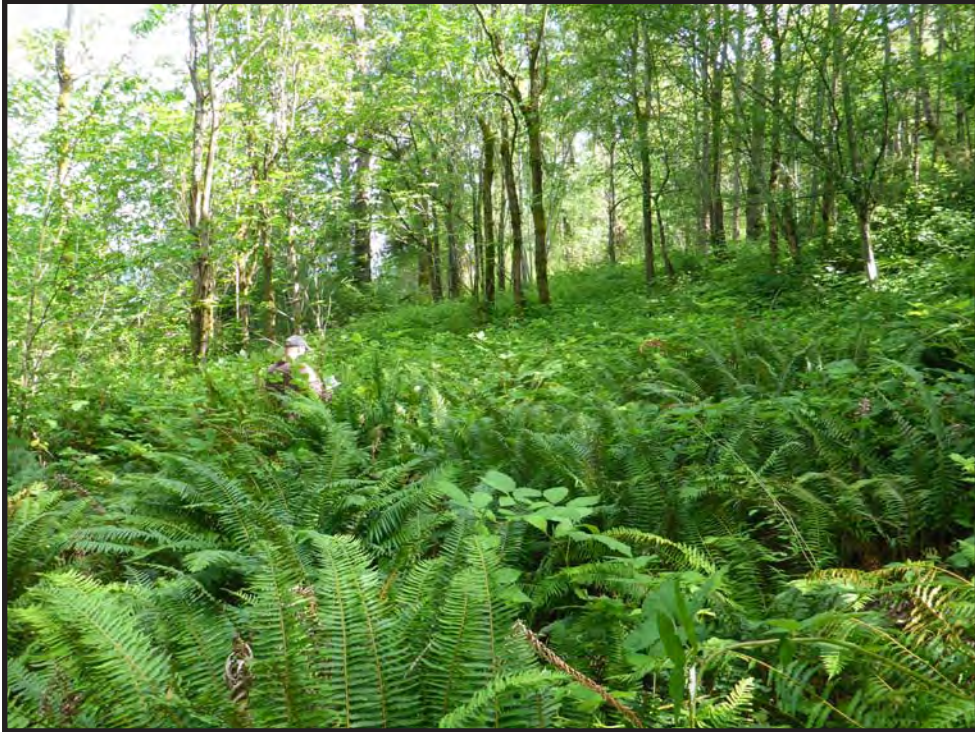
Figure 28. Zone 52, a broad, sloping terrace above the cut for the northbound lanes of I-405. The crew is excavating ST 205 in this view to the north.

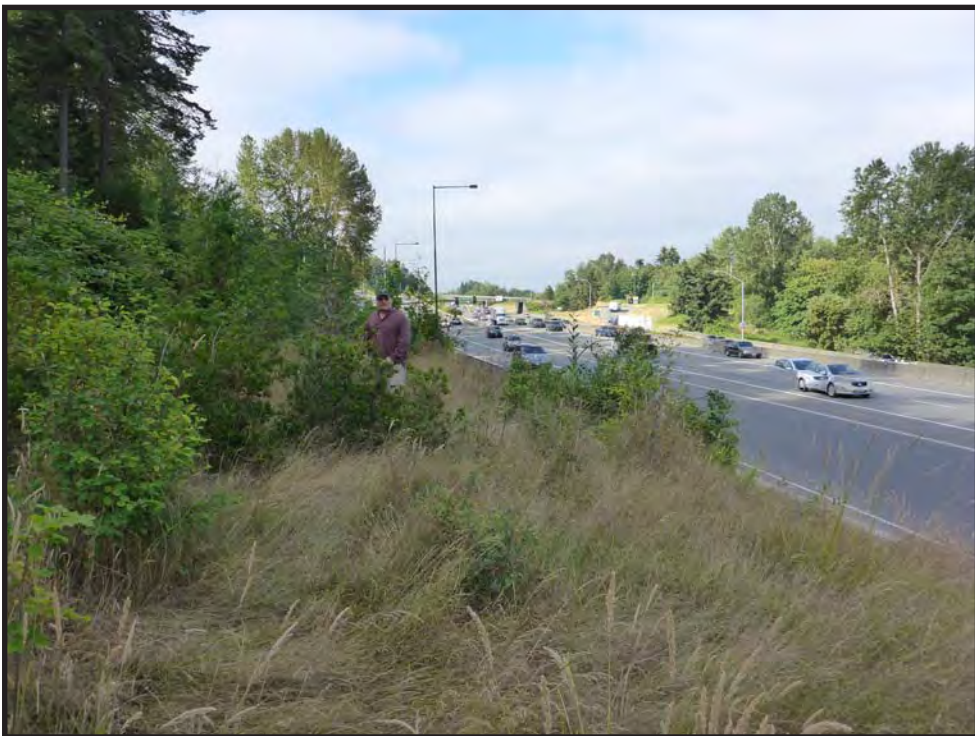
Figure 29. Zone 53, a narrow, sloping terrace above the cut for the northbound lanes of I-405. The crew is excavating ST 197 in this view to the southwest.

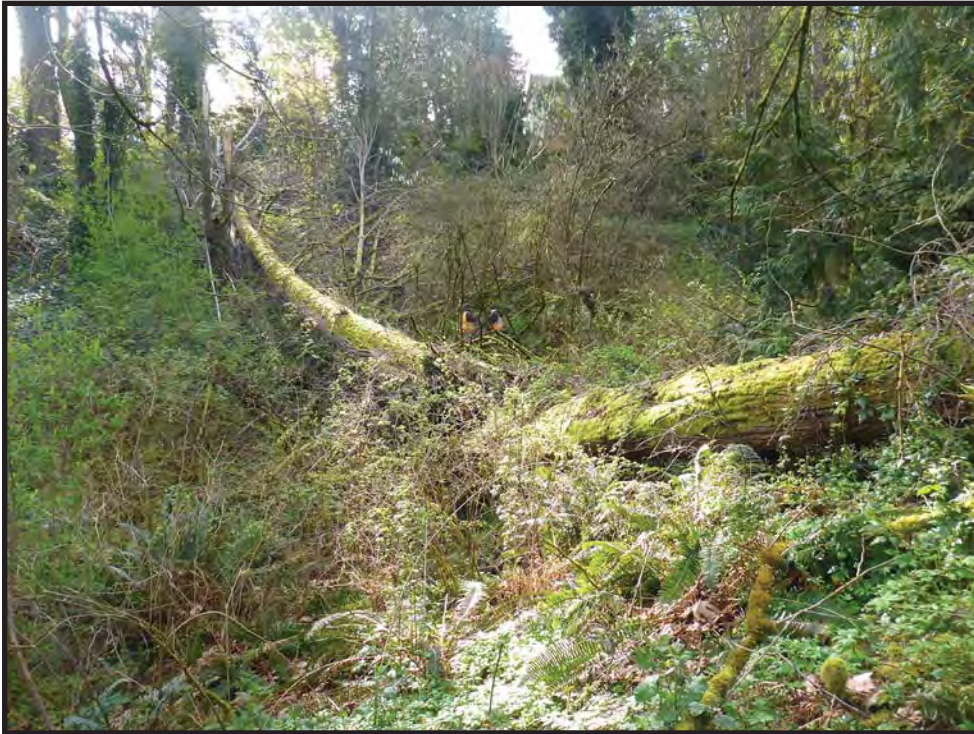
Figure 30. Zone 57 is a deeply incised stream channel formed by a perennial stream and includes the associated wetland abutting the elevated fill slope of I-405. The crew is excavating ST 142 in this view to the northeast.

This restricted zone is centered on a deeply incised stream cut formed by a perennial stream and includes the associated wetland abutting the elevated fill slope of I-405 (Figure 30). It is bound on the north by the I-405 northbound off-ramp to Coal Creek Parkway, and on the south by fenced residential properties. Native sediments, mapped as Holocene alluvial sandy loam, were encountered in all six shovel tests (STs 140, 142, 144, 146, 151, and 153) excavated in and adjacent to Zone 57 (see Figure B.16).

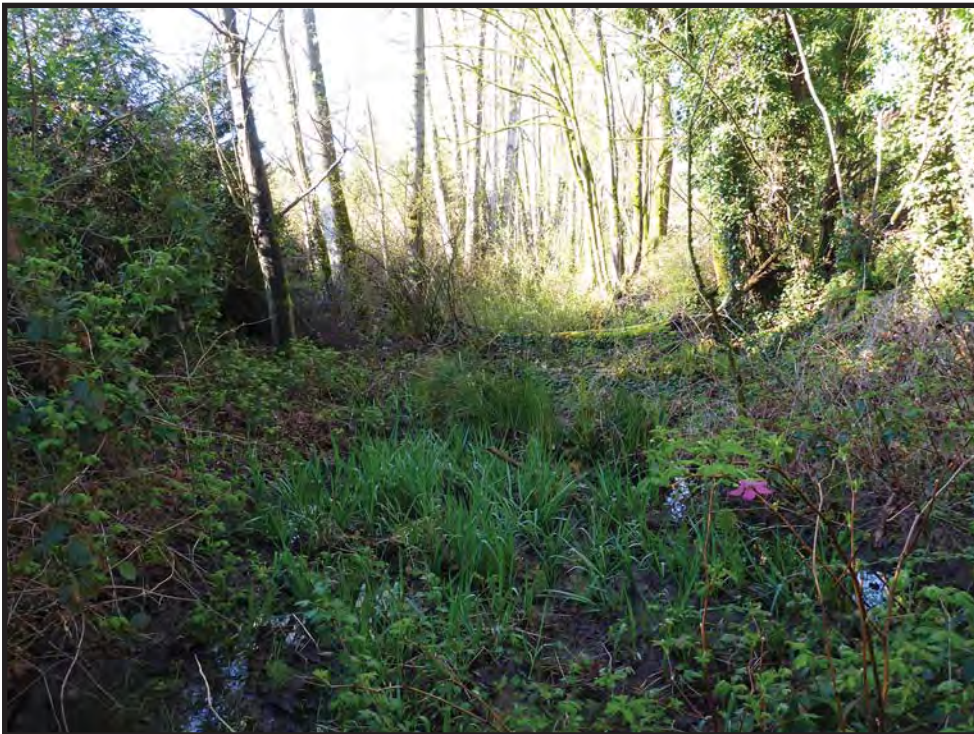
Figure 31. Wetlands associated with Coal Creek at the north end of Zone 58. View to the south.

This short, narrow restricted zone parallels the existing Coal Creek channel and associated wetlands (Figure 31). It is bound on the north by Coal Creek Parkway, on the east and south by the toe of the I-405 southbound lanes road fill prism, and on the west by the tracks and grade of the Northern Pacific Lake Washington Belt Line. Native sediments, mapped as Holocene alluvial sandy loam (Coal Creek), were encountered in all three shovel tests (STs 182, 190, and 191) excavated in Zone 58 (see Figure B.16).

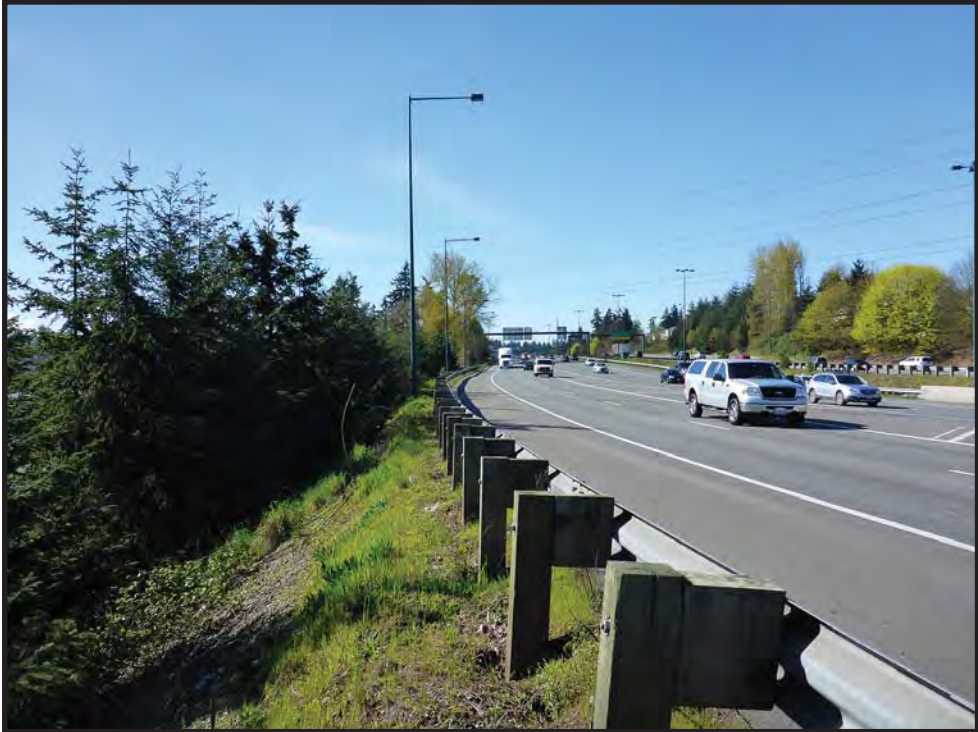
Figure 32. Elevated fill slope on the eastern edge of I-405 typical of Zone 61. View to the southwest.

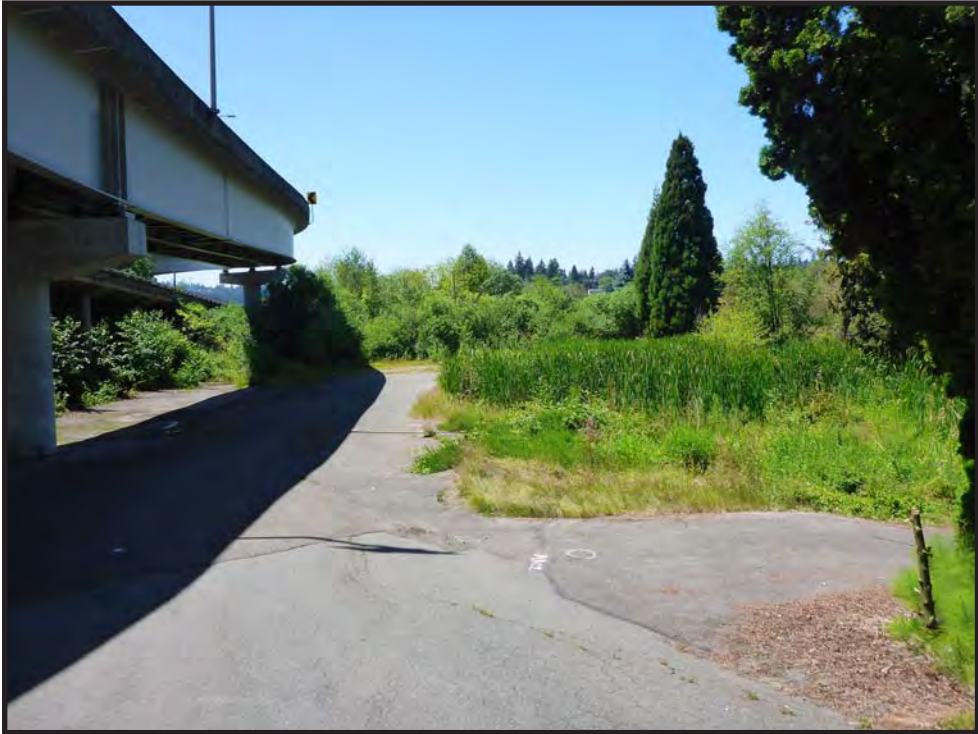
Figure 33. Overview to the west of paved parking lot and former structure location beneath the westbound lanes of I-90 near the north end of Zone 61. This parcel has reverted back to native marshy vegetation of Mercer Slough.

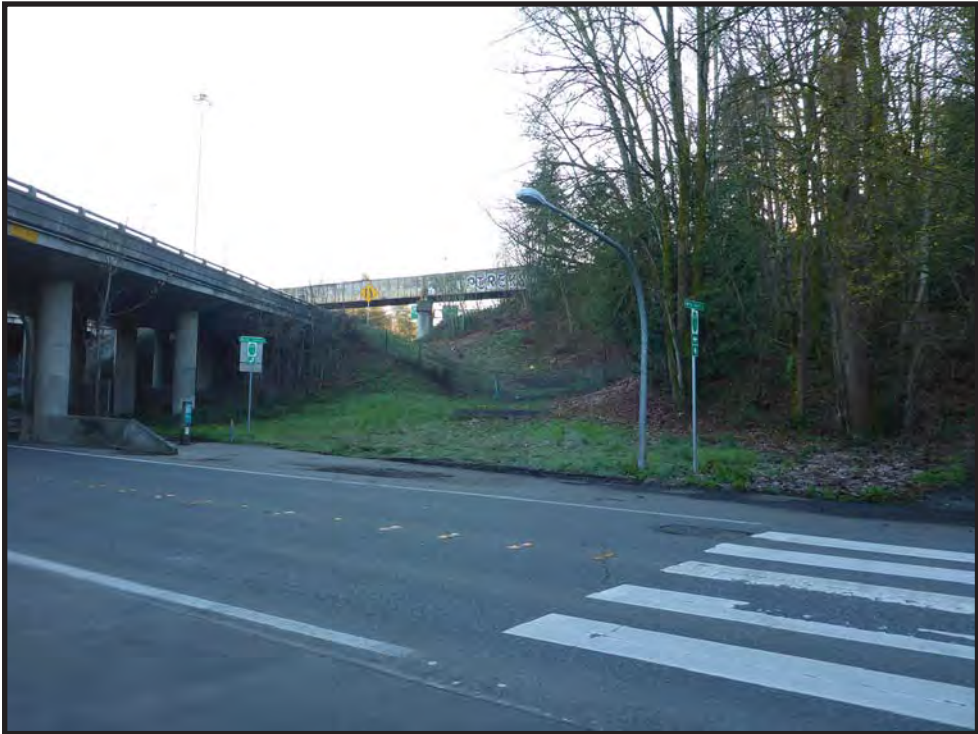
Figure 34. View from Lake Washington Boulevard showing an I-90 overpass to the left and the Northern Pacific Lake Washington Belt Line steel bridge crossing I-90 in Zone 65, view to the east. The utility vault is visible in the grassy area south of I-90.

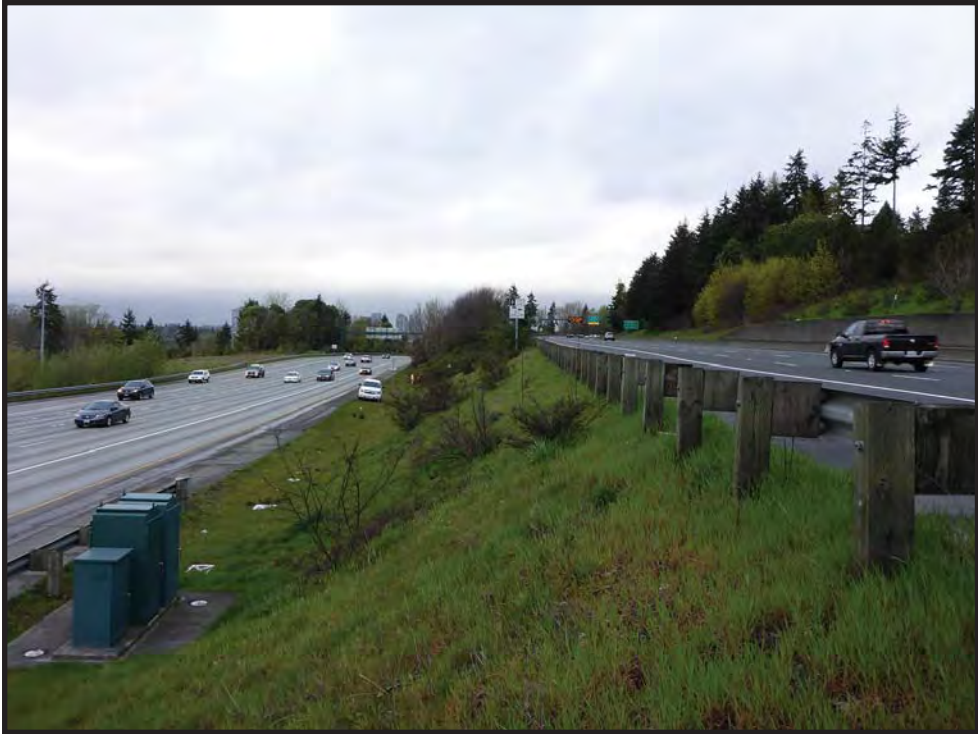
Figure 35. Overview of Zone 69, the paved lanes of I-405 extending north from the I-90 interchange at MP 11.30 to the north end of the project resource evaluation area. The crew is excavating ST 156 in this view to the north.

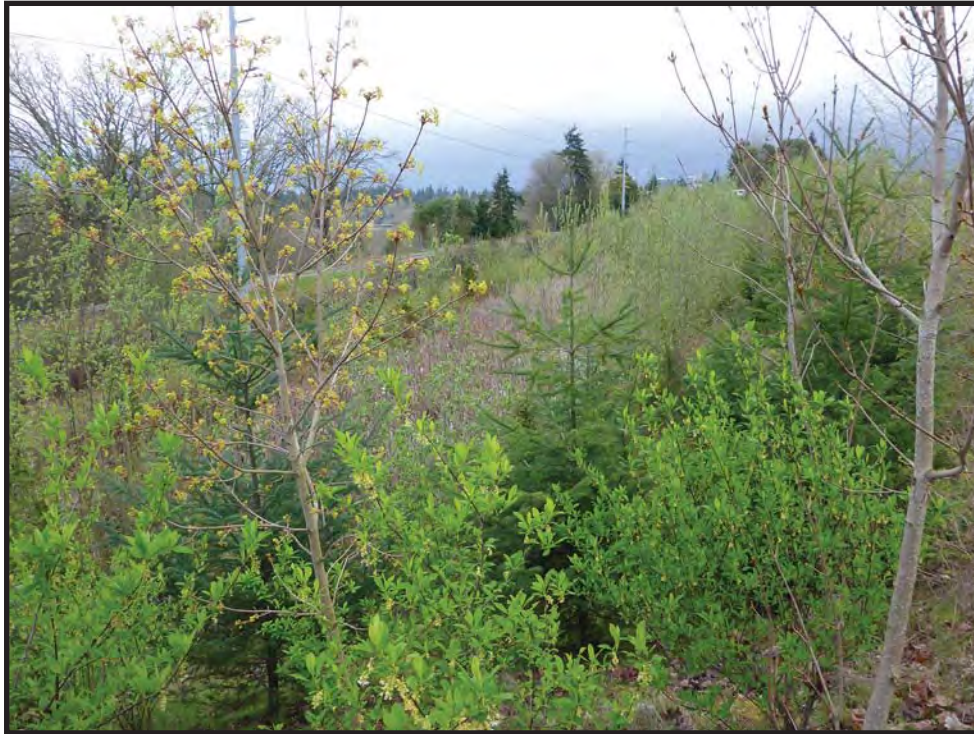
Figure 36. Overview of Zone 71, the storm water retention pond, evident by the cattails in the center of this photograph, and overgrown gravel access road along the western edge are shown in this photograph to the northwest.

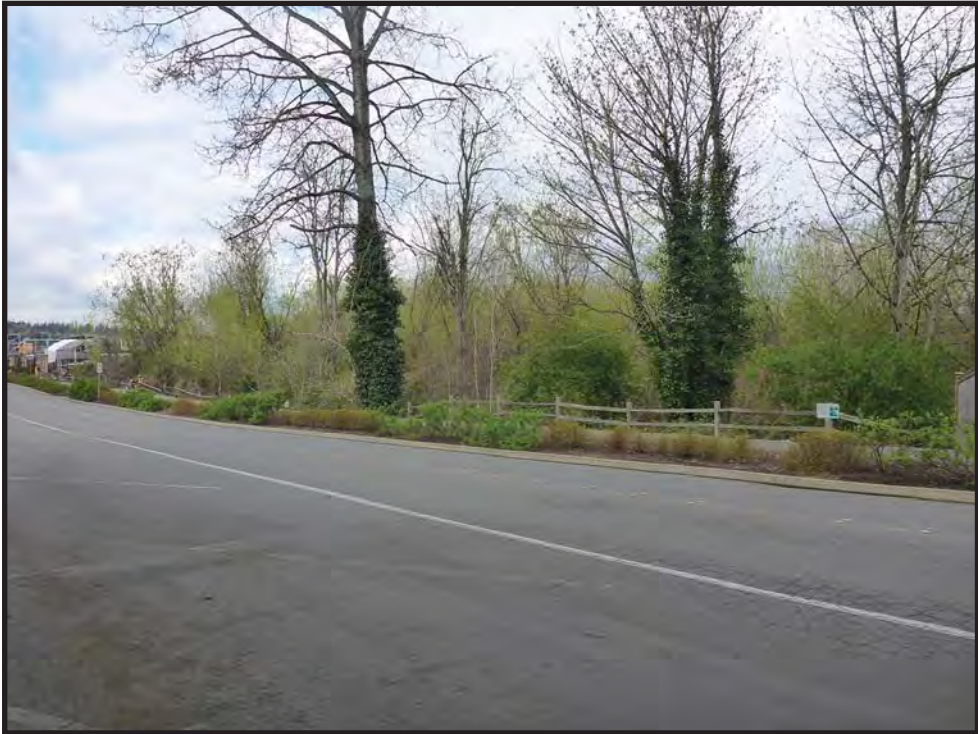
Figure 38. Crew excavating shovel tests along SE 40th Street (east of the Seattle Boat Company). View to the northwest.

The central portion of this area includes the spur of SE 40th Street west from the intersection with Lake Washington Boulevard (Figure 38). Sediment compaction halted excavation before the base of compacted fill was identified in the four shovel tests (STs 130, 132, 139, and 141) excavated along SE 40th Street (see Figure B.18).

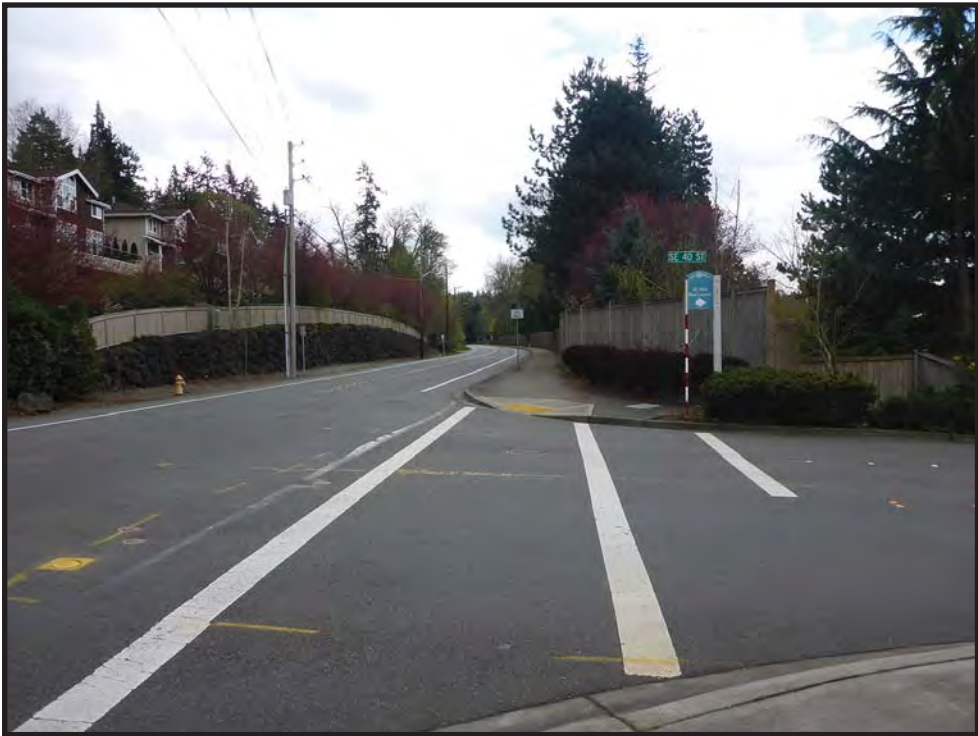
Figure 39. View along Lake Washington Boulevard from SE 40th Street. View to the south.

South of SE 40th Street along Lake Washington Boulevard is occupied by a relatively new residential subdivision (Figure 39). Six shovel tests (STs 134, 136, 143, 145, 147, and 149) were

excavated at the south end of this area between Lake Washington Boulevard and I-405 (see Figure B.16). Native sediments, capped by fill, were identified in four of the shovel tests. Intact sediments were gravelly loamy sands mapped as gravelly till with compact lodgement till, formed under advancing glacial ice, capped by loose gravelly ablation till which formed after the retreat of glacial ice during the late Pleistocene (Soil Survey Staff 2015).

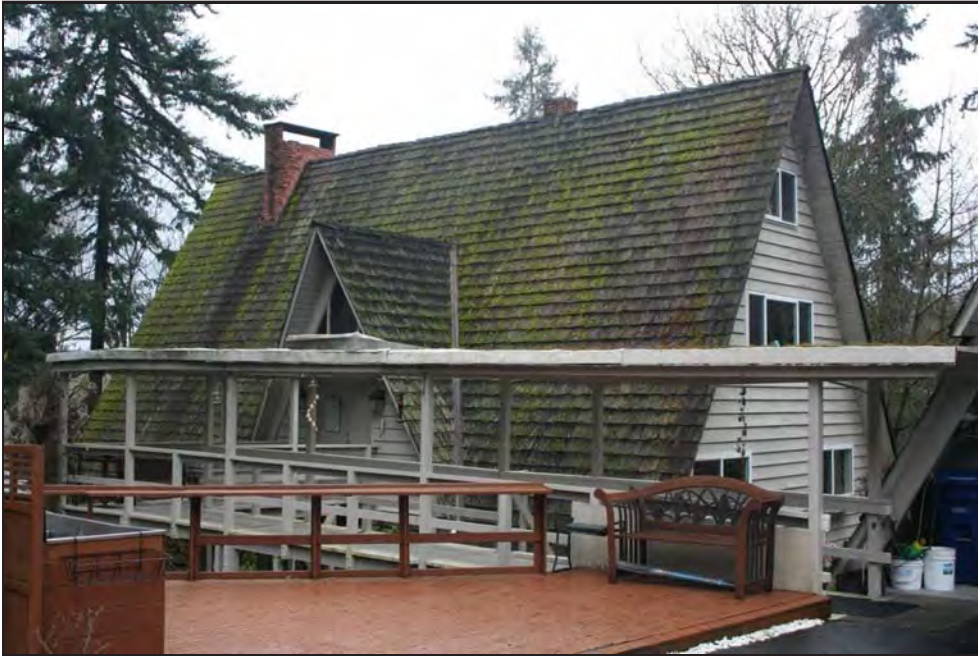
Figure 41. Paukstis house, 11620 SE 45th Place, south (front) and east elevations. The view is to the northwest.

The A-frame was an off-shoot of the rise of vacation homes across America in the mid-twentieth century. These developments were spearheaded by designers such as Andrew Geller and John Carden Campbell, among others. At the corporate level, the advancement was championed by the Douglas Fir Plywood Association (DFPA), who elaborated on designs by amateur builder David Hellyer. The DFPA, based in Tacoma, was instrumental in marketing the A-frame across the Pacific Northwest. This house was built in 1961, when the A-frame was still a popular form, not just for vacation cabins, but for residences as well. Despite its vinyl sash windows, this house is eligible for listing in the NRHP as a relatively rare example of the A-frame house in an otherwise typical modern neighborhood.

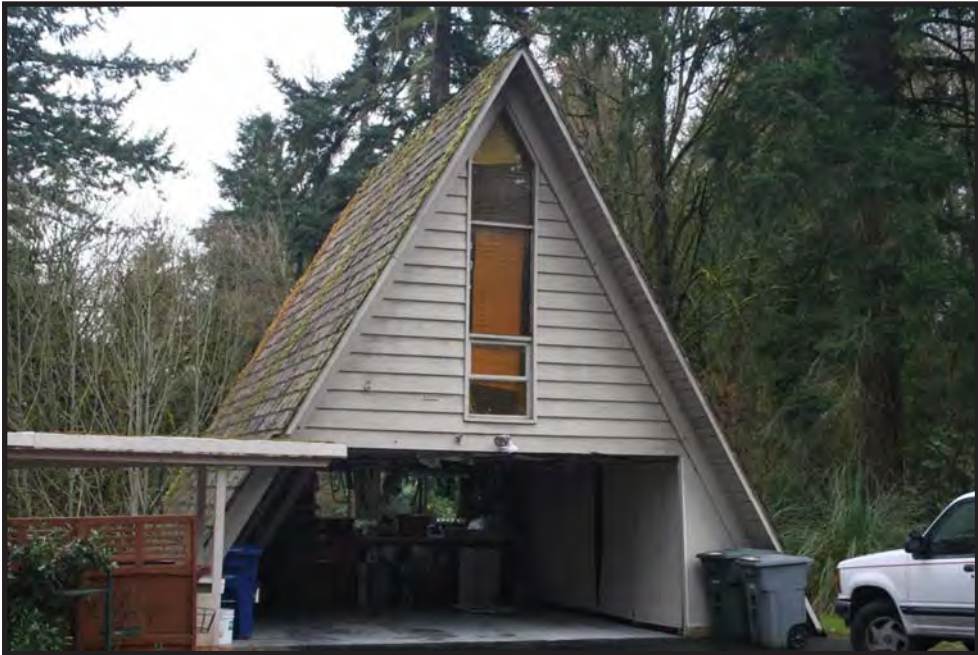
Figure 42. Paukstis garage, 11620 SE 45th Place, south and west elevations. The view is to the northeast.

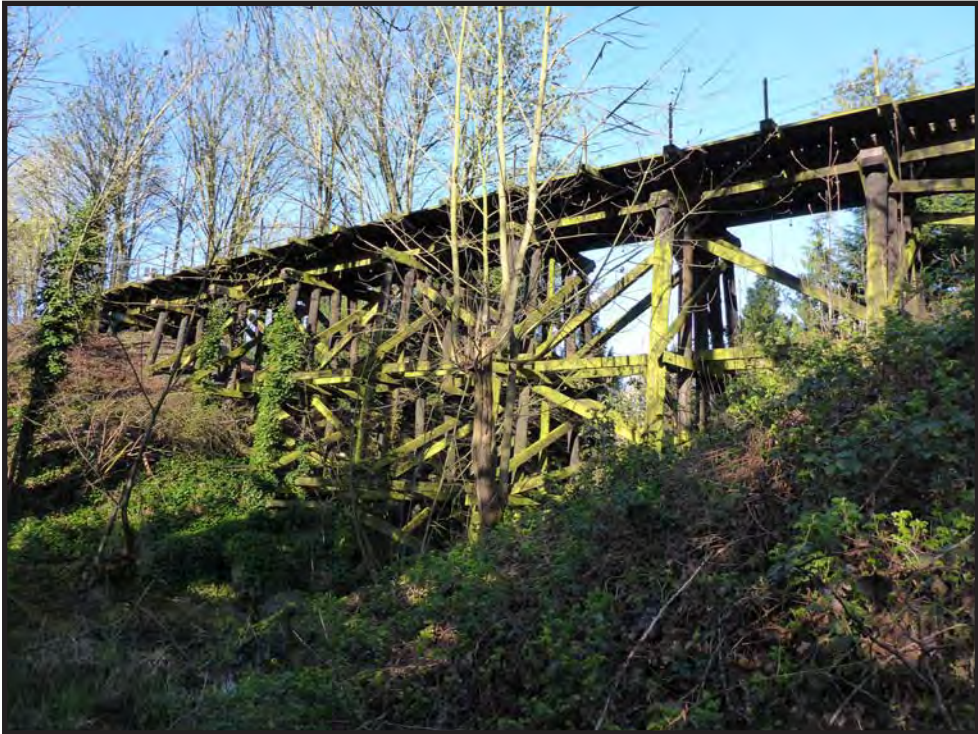
Figure 43. Northern Pacific Lake Washington Belt Line, trestle over Coal Creek in Zone 58, view to the southwest.

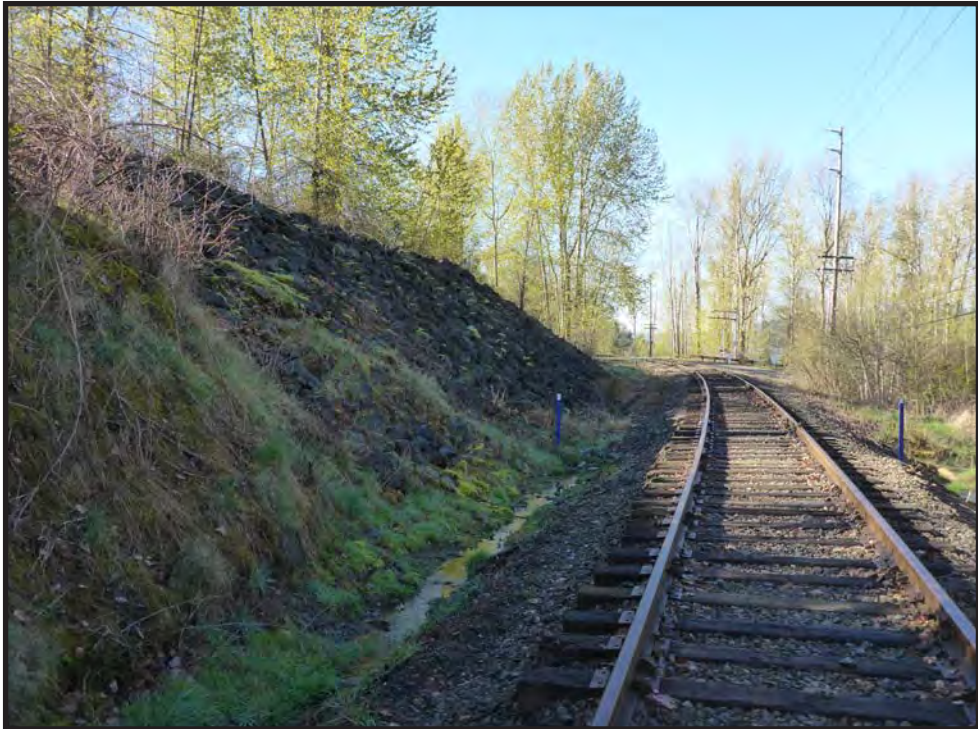
Figure 44. Northern Pacific Lake Washington Belt Line, riprap slope along railroad tracks in Zone 49, view to the southwest.

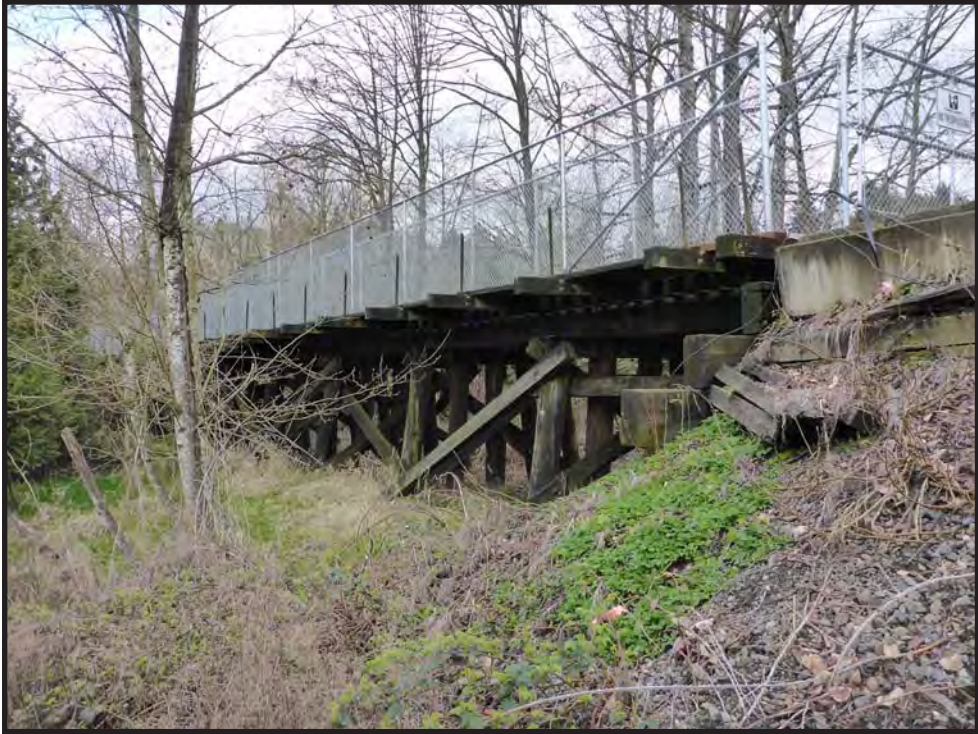
Figure 45. Northern Pacific Lake Washington Belt Line, trestle over Ripley Lane at the south end of Zone 35, view to the southeast.

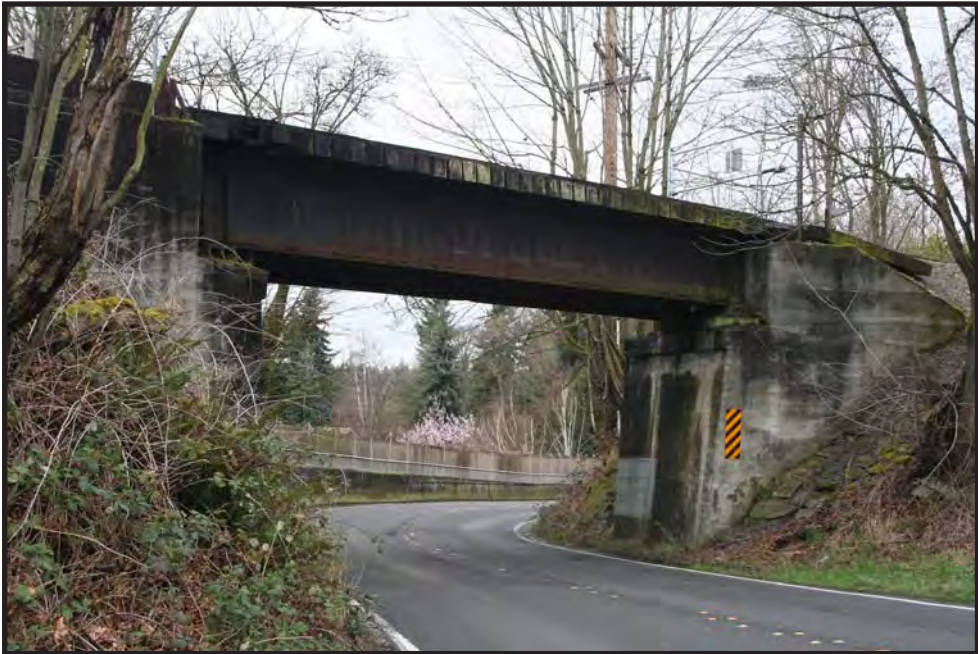
Figure 46. Lake Washington Boulevard overpass, view to the north.

taining wall is situated at the northwest corner of the abutment. At the north end of the overpass is a chain link fence and gate controlled by a battery powered electronic device (Figures 46 and 47).

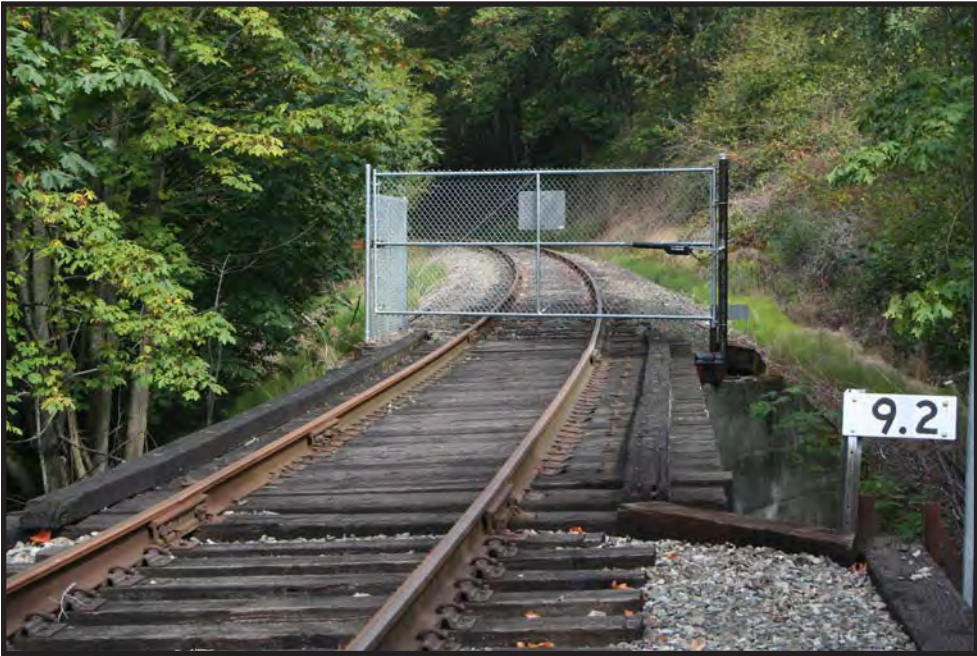
Figure 47. Lake Washington Boulevard overpass deck, view to the northwest.

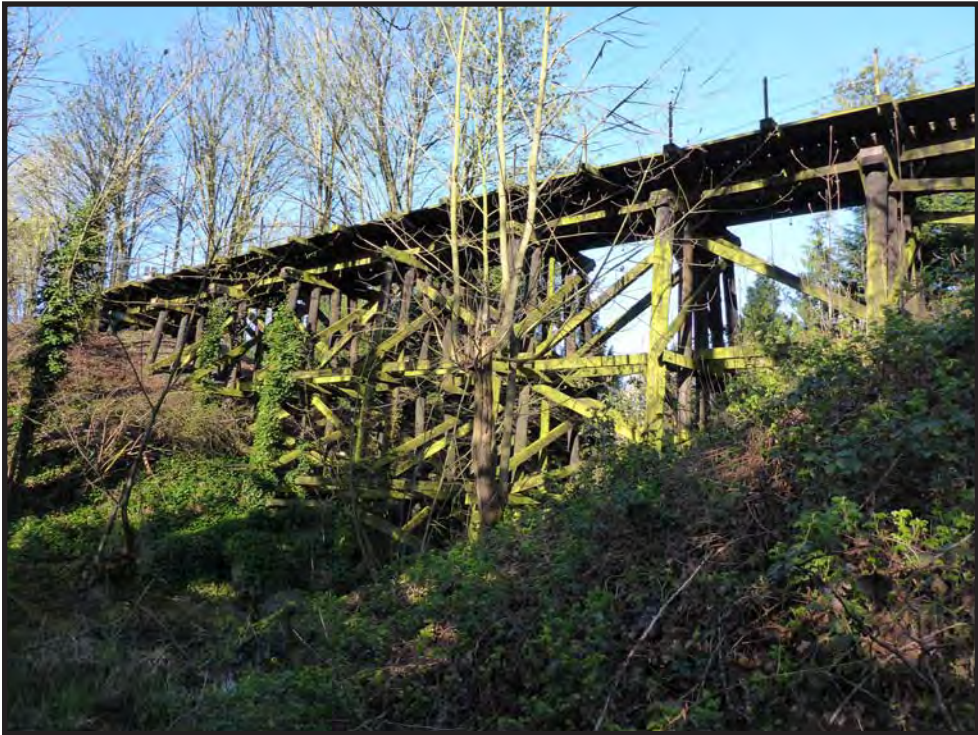
Figure 50. Coal Creek trestle, view to the northwest.

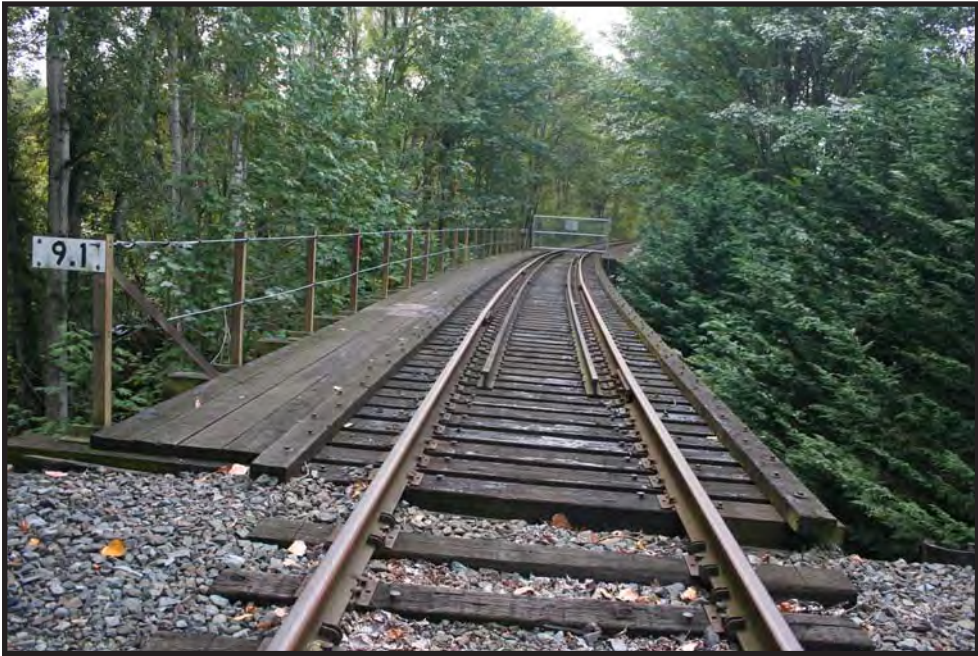
Figure 51. Coal Creek trestle, deck, view to the northeast.

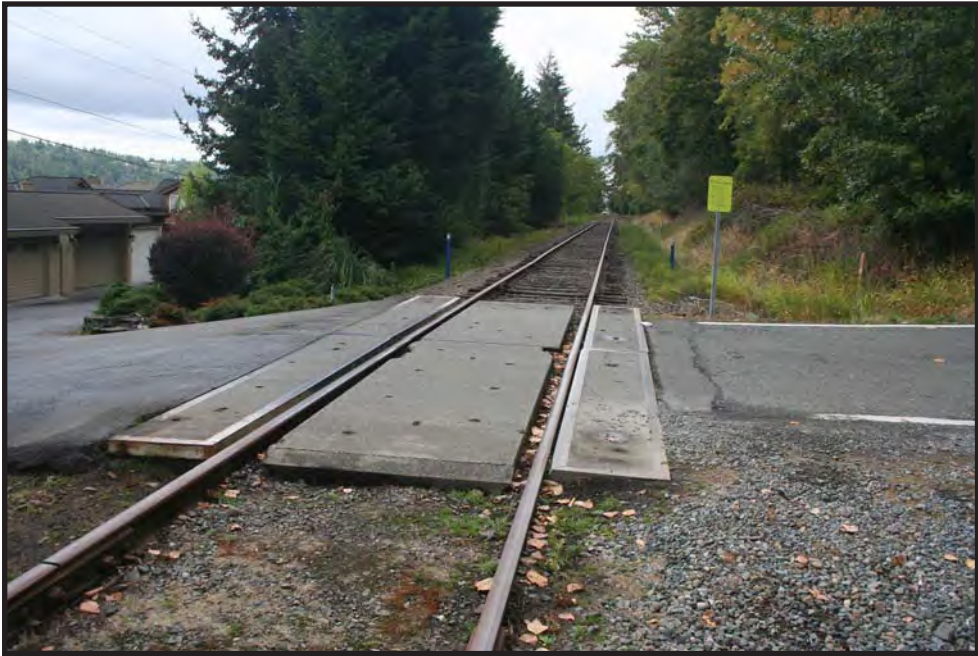
Figure 57. Grade crossing at Hazelwood Lane, view to the north.

This is a 9-foot wide grade crossing with a pre-cast concrete surface (see Figure B.13; Figure 57).

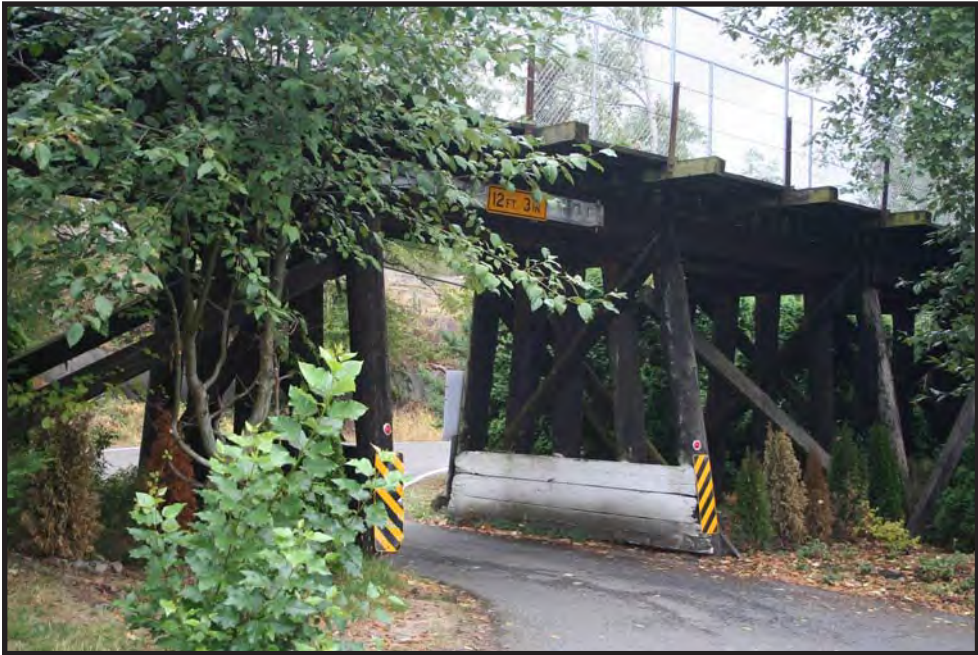
Figure 58. Ripley Lane trestle, underpass, view to the north.

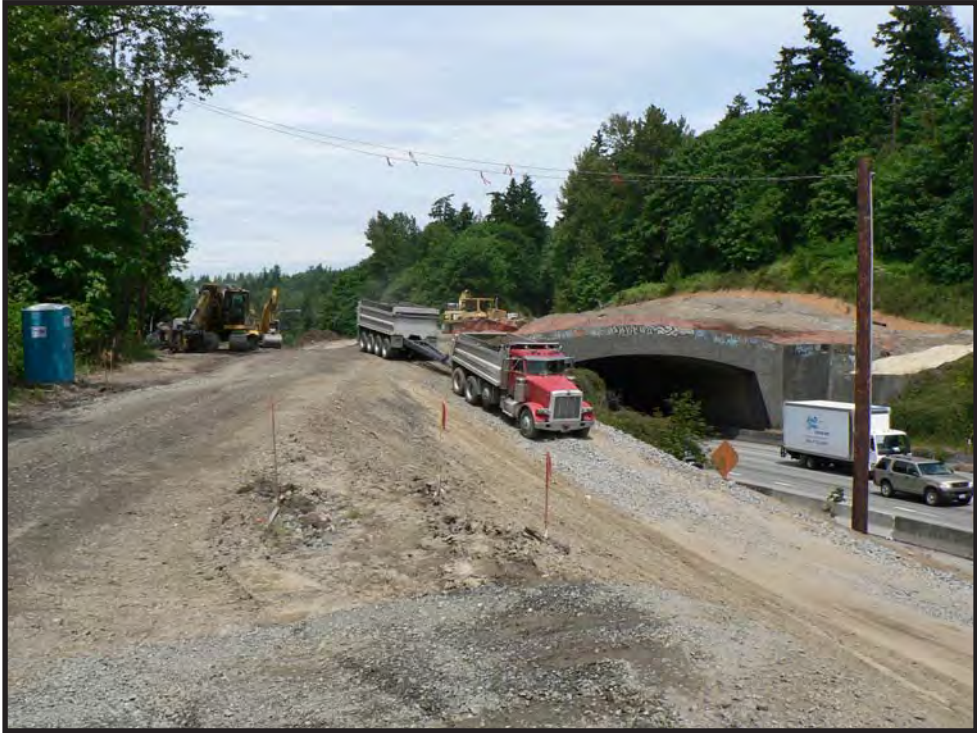
Figure 60. Wilburton Tunnel in 2008 prior to demolition, view to the north. Note southbound I-405 traffic beneath the overpass. (Photograph courtesy of Tom Doolittle, Doolittle Construction.)

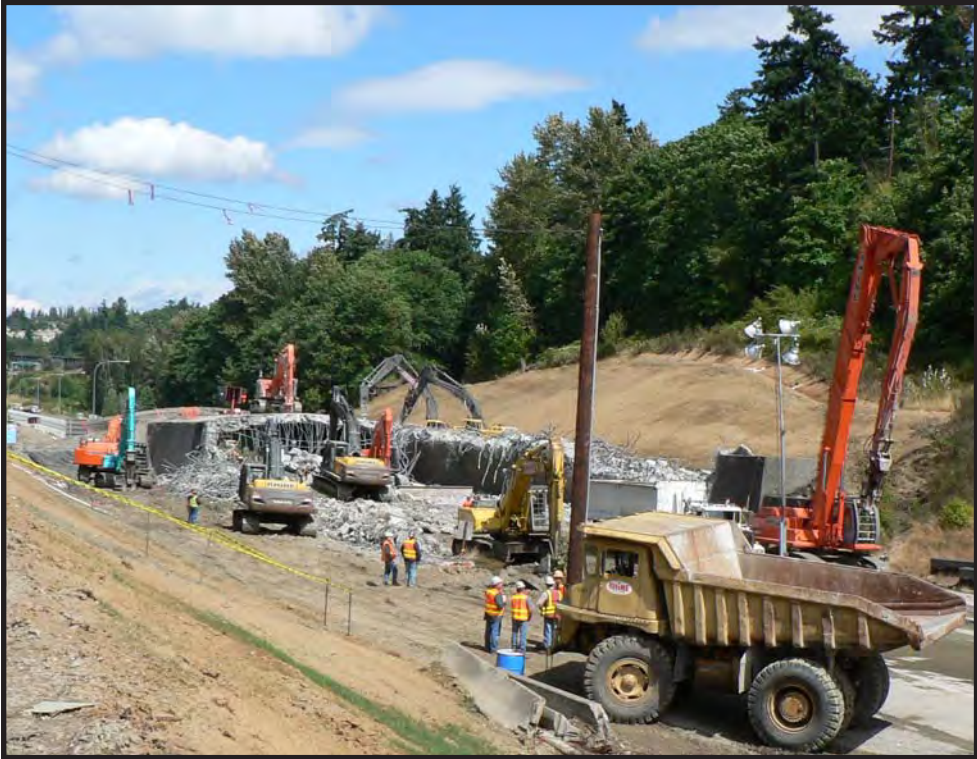
Figure 61. Wilburton Tunnel demolition in 2008, the view is to the north. (Photograph courtesy of Tom Doolittle, Doolittle Construction.)

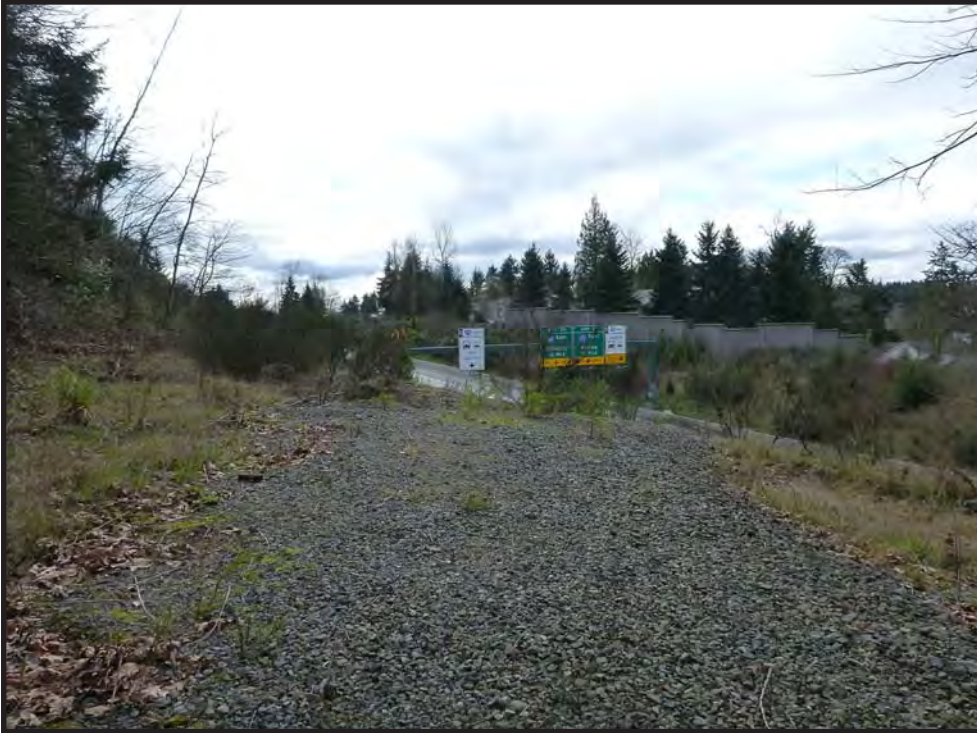
Figure 62. Overview of the former Wilburton Tunnel location in 2016, view to the southwest.

This 300-foot-long cast-in-place concrete tunnel once carried rail traffic on the Lake Washington Belt Line over I-405. The former tunnel location is north of the current Project (see Figure A.4). The tunnel was built in the 1972, during construction of the I-405 route. It was demolished in 2008, a year after rail traffic ended, to allow for the broadening of the I-405 right-of-way (Figures 60 and 61). This action created a gap in the rail bed where I-405 passes (Figure 62). Plans to close the gap with a proposed pedestrian/bicycle bridge are being formulated by King County and WSDOT.

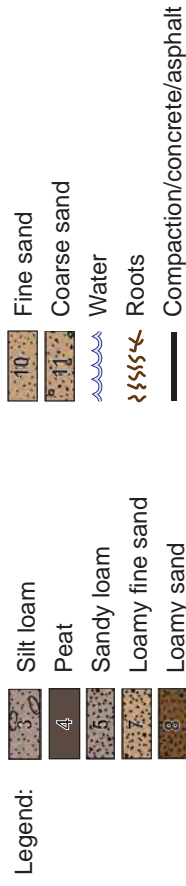
Figure D.3. Profile drawings of shovel tests excavated in Zones 29-31 and 33-34.

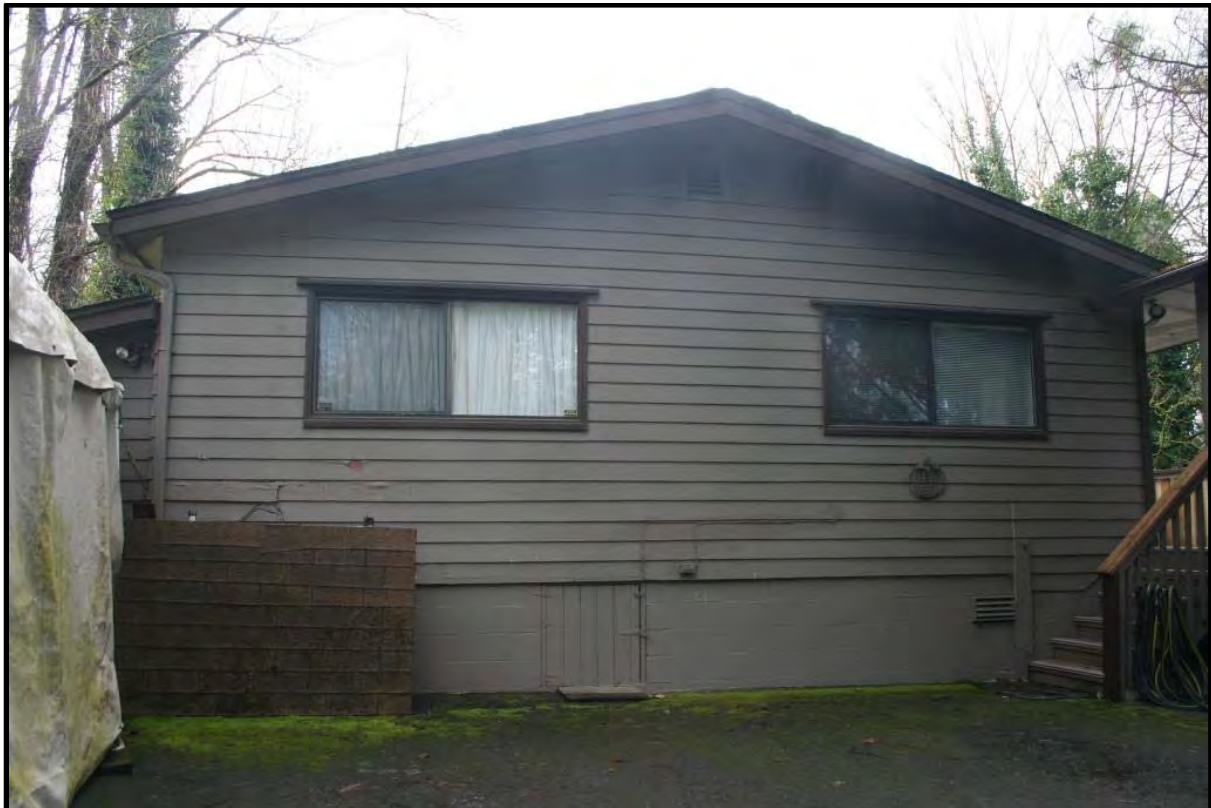
Physical Description: This residence is a 1-story wood frame structure with a side-gabled rectangular plan. The shallow-pitched roof is covered with composition shingles and has moderately wide enclosed eaves, except for the west (front) elevation, where the eaves are wide and supported by knee braces. Exterior wall surfaces are clad with horizontal wood siding, except for the west elevation, which is finished with stucco. The foundation is concrete block. Windows are metal sash and include both fixed and sliding units. The front features two sets of double French doors, facing a full-width wood deck with railing. On the south elevations is a secondary entry beneath a shed-roofed open porch canopy.

Significance Narrative: This is a modest Ranch Style house built in 1953, when that style was beginning its long run of popularity. Ranch characteristics include the horizontal elevational profile, shallow-pitched roof, and wide eaves to the front. Otherwise it is a rather low key rendition of the style. The windows appear to be metal sash replacements. Even if they are original, this house lacks sufficient distinction for listing in the National Register of Historic Places.

Figure F.1. Chan House, 4240 Lake Washington Blvd., north elevation, view to the south.

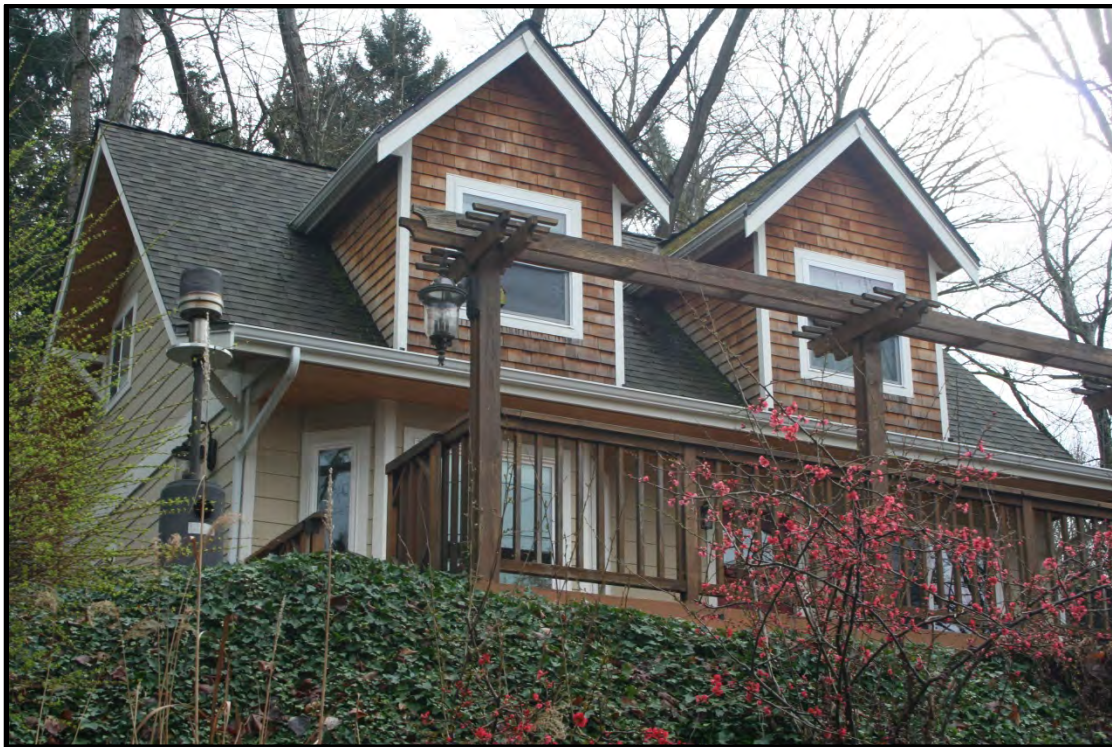
Physical Description: This residence is a 1-1/2-story wood frame building with a rectangular plan. The side-gabled roof is covered with composition shingles and features wide, unenclosed eaves, exposed rafter ends, fascia boards, and knee-braces in the gables. Two prominent gabled dormers are placed on the west (front) roof slope. The fronts of the gables are clad with wood shingles, while other exterior surfaces are clad with wide wood clapboard siding. The foundation is poured concrete. The windows are all vinyl sash and include both fixed and sliding types. To the front is a full-width wood deck with railings and a pergola.

Significance Narrative: This house was built in 1953, and is sort of an anomaly due to its Craftsman characteristics, which were in vogue in the 1920s and 1930s. Craftsman influence is seen primarily in the roof features, such as the open eaves, exposed rafter ends, fascia boards, and knee-braces. Otherwise the house is a mostly vernacular design. All the windows have been replaced with modern vinyl units, the shingles of the gable faces were probably recently applied, and the deck is relatively recent. Although the house retains good integrity of its historical appearance, changes to the original construction materials render it ineligible for listing in the National Register of Historic Places.

Figure F.2. *Morriseau House, 4256 Lake Washington Blvd., west elevation, view to the southeast.*
