I-405, Tukwila to I-90 Vicinity Express Toll Lanes Project (MP 0.0 to 11.9)

Attachment E: Cultural Resources Survey

**Cultural Resources Survey for the Washington State
Department of Transportation's I-405 Renton to Bellevue
Improvement Project: SR 169 to I-90,
King County, Washington**

Short Report DOT2016-06
Archaeological and Historical Services
Eastern Washington University

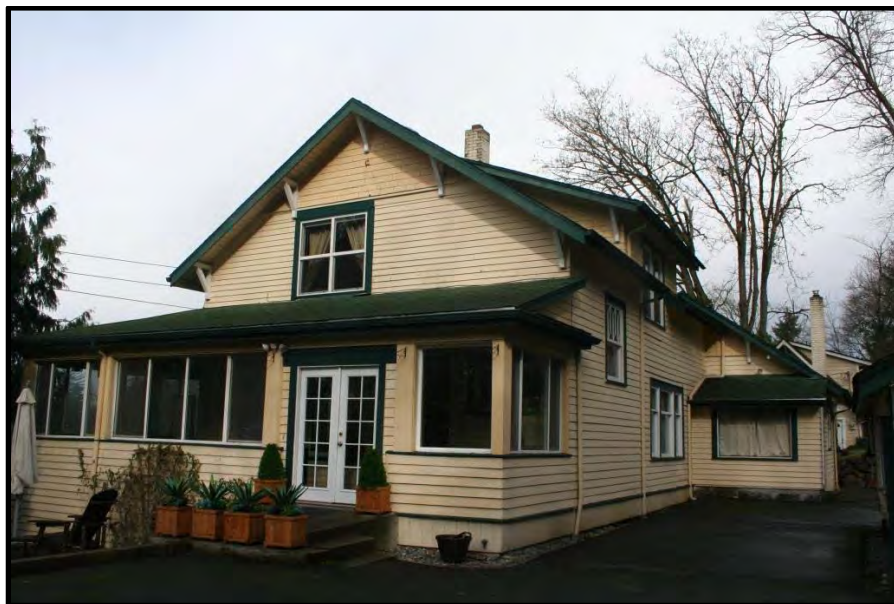
Physical Description: This residence is a 1 1/2-story wood frame building with a daylight basement level below. It has a rectangular front-gabled plan. The roof is covered with composition shingles and has wide eaves fascia boards and knee-braces. Shed-roofed dormers are situated on the east and west slopes. A brick chimney emerges from near the roof crest. An enclosed 1-story porch wraps around the south and west sides of the house. A short shed-roofed addition extends from the north end of the east elevation. Exterior wall surfaces are clad with horizontal clapboard siding except for the dormer walls and the upper portions of the gables, which are clad with wood shingles. The foundation is poured concrete. A double set of French doors provides a front entry through the porch. Windows are mostly vinyl replacement units, including large picture windows in the porch, as well as other fixed sash and double-hung windows elsewhere. Directly east of the house is a wide, front-gabled garage, with a composition roof, horizontal wood siding, and knee braces in the gable faces. The vehicle door is missing.

Significance Narrative: This house was built in 1911, a little early to place in the Craftsman Style designation, although it does exhibit wide eaves and knee-braces. Other than that it is a combination of vernacular elements. If the wrap around enclosed porch is not an addition, it is certain that the large picture windows are. Furthermore, all of the original windows have been replaced by vinyl sash units. These extensive changes to the plan and windows render this building ineligible for listing in the National Register of Historic Places.

Figure F.3. Schulman House, 4304 Lake Washington Blvd., south and east elevations, view to the northwest.

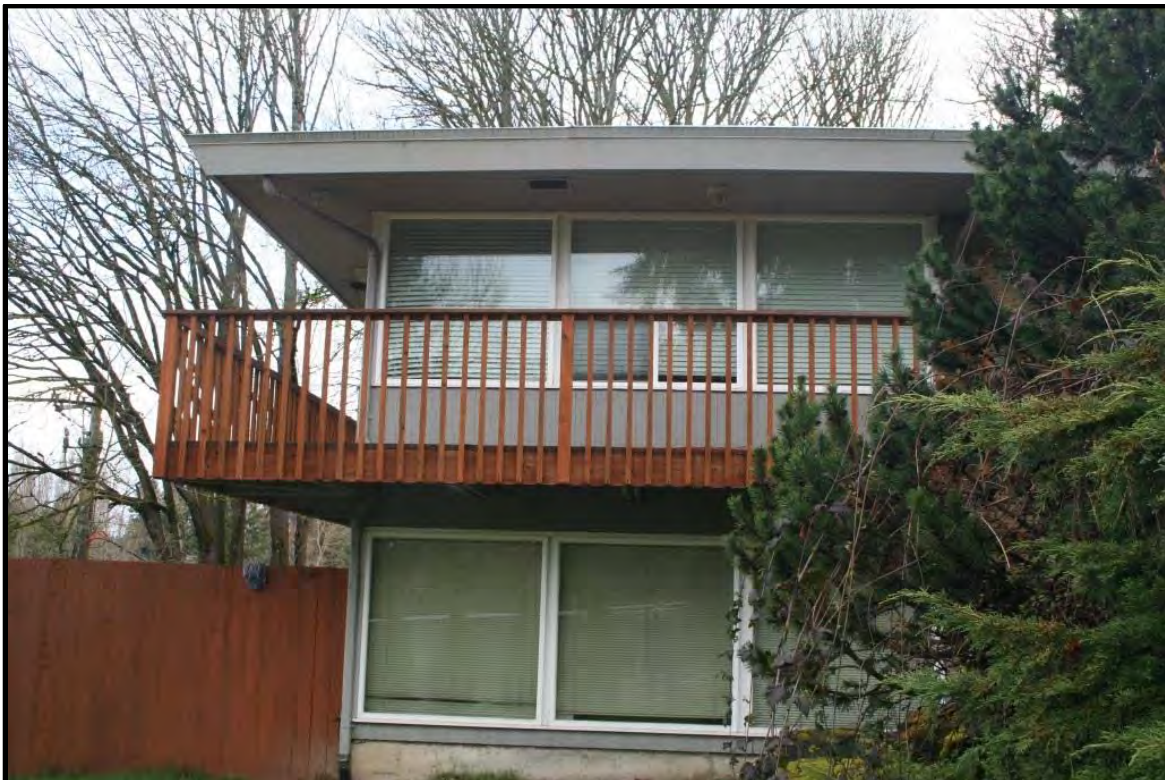
Physical Description: This residence is a 1-story wood frame building with a roughly rectangular plan. It is situated on a slope, allowing for a day-light basement level at the southwest corner. The shallow-pitched, hipped roof is covered with composition shingles and has widely-overhanging, enclosed eaves. A massive brick chimney with a rectangular cross-section is located on the west side of the roof peak. Exterior wall surfaces are clad with wide horizontal wood siding. The foundation is poured concrete. Two vehicle entry doors are placed on the south (front) elevation, accessing an attached garage. All windows are vinyl sash and include fixed and sliding units. A wood deck and railing wraps around the south (front) and west elevations.

Significance Narrative: This house was built in 1956, just as the Ranch Style was wildly gaining in popularity, becoming the dominant residential idiom in America. Diagnostic elements present include the horizontal facade profile, shallow-pitched roof with widely overhanging, enclosed eaves, massive masonry chimney, and attached garage. The primary departure from architectural integrity is the replacement of original wood sash windows with vinyl sash units. This alone is enough to precluded listing in the National Register of Historic Places.

Figure F.4. Woo House, 4436 119th Avenue SE, south elevation, view to the north.

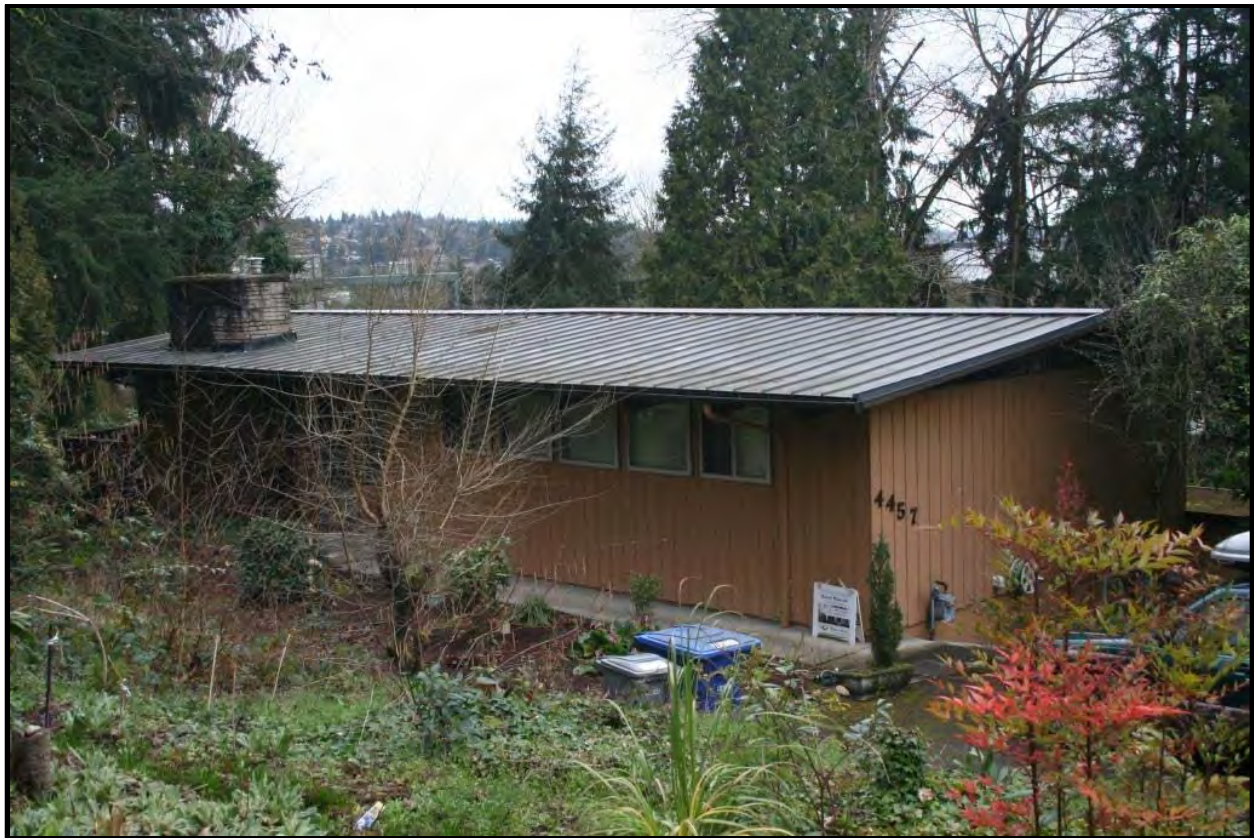
Physical Description: This house is a 1-story wood frame structure with a rectangular plan. The shallow-pitched roof is covered with metal sheeting. A brick chimney with a rectangular cross-section emerges from the south roof slope. The eaves are wide and unenclosed. The foundation is poured concrete. Exterior wall surfaces are clad with vertical board siding. Windows are vinyl sash and include both fixed and sliding units. A wood deck spans the length of the east (front) elevation.

Significance Narrative: This residence was built in 1958, when the popularity of the Ranch Style was at its height. This is a rather minimalist rendition of the style. Diagnostic elements include the 1-story horizontal profile, the shallow-pitched roof, and the massive masonry chimney. The open eaves are a departure, however. The house exhibits poor integrity, emphasized by the metal roof and the vinyl windows. It is not eligible for listing in the National Register of Historic Places.

Figure F.5. Wisecarver House, 4457 119th Avenue SE, east and north elevations, view to the southwest.

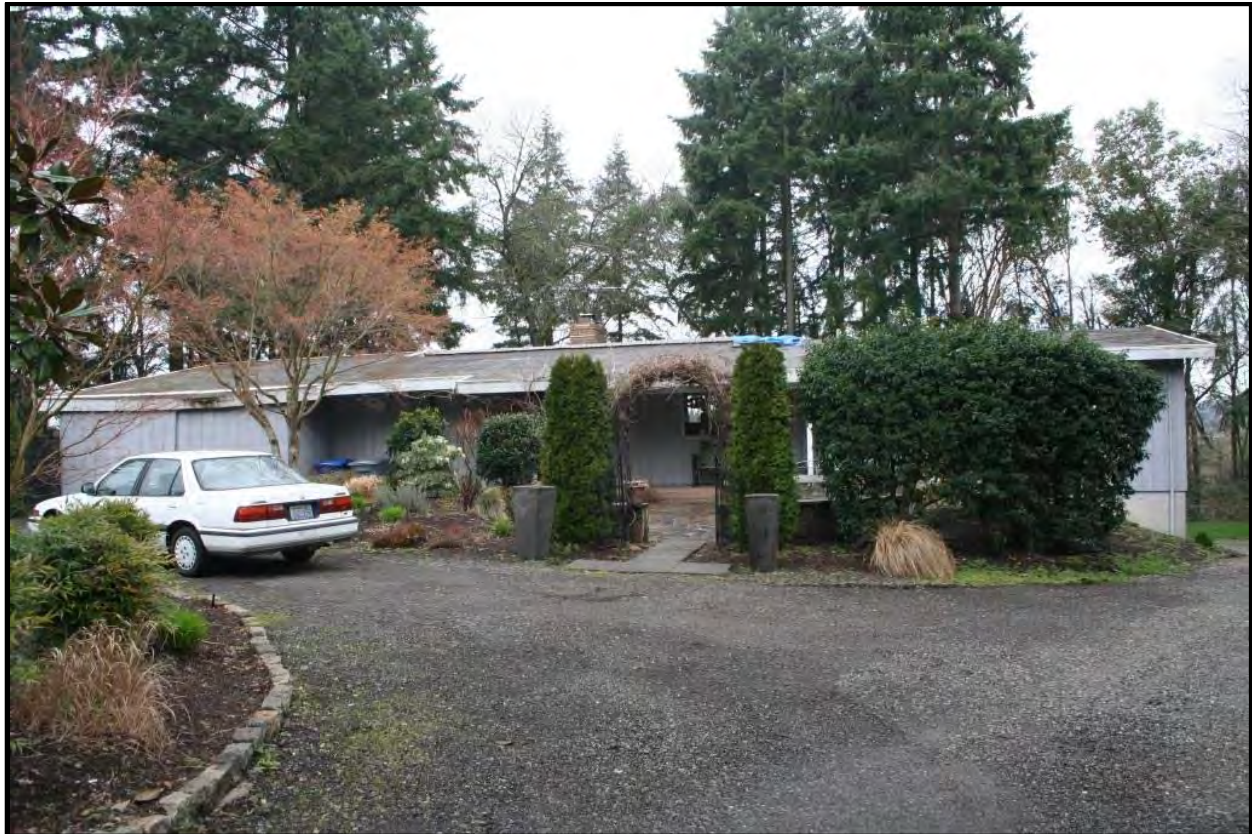
Physical Description: This house is a 1-story wood frame building with a rectangular plan. The shallow-pitched front-gabled roof is covered with rolled asphalt and has moderately-wide enclosed eaves. A brick chimney with a rectangular cross-section emerges from near the roof crest. Exterior walls are clad with vertical board siding. The foundation is poured concrete. All windows are vinyl sash fixed and sliding replacement units. A garage door is placed to the left side, consisting of a sliding door clad with the same material as the house walls.

Significance Narrative: This residence, built in 1958, is a modest example of the Ranch Style which was popular at the time. The roof has a more shallow pitch than is normal and currently has a temporary covering of rolled asphalt roofing. It has the horizontal elevational profile of the Ranch Style, but the windows have been altered. These and other factors render the house ineligible for listing in the National Register of Historic Places.

Figure F.6. Cerna House, 11610 SE 45th Place, east elevation, view to the west.

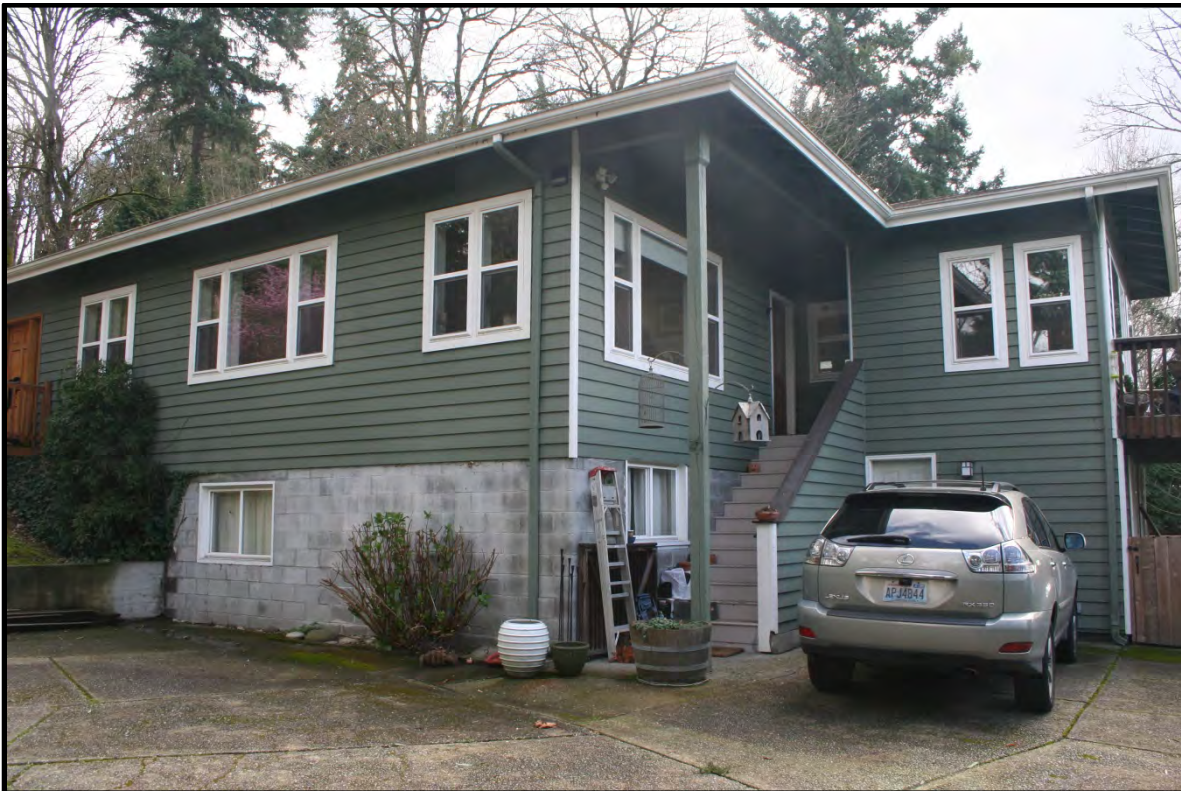
Physical Description: This residence is a 1-story wood frame building with an L-shaped plan. The shallow-pitched hip roof is covered with composition shingles and has wide unenclosed eaves. A brick chimney emerges from near the central crest. Exterior walls are clad with horizontal wood clapboard siding. The foundation is concrete block. Windows are vinyl sash and include both fixed and double-hung units. The house is situated on a slope, allowing for a day-light basement level. Formerly, a garage door was located on the north elevation at this level. That opening has been sealed shut with concrete blocks. The front entry is at the top of a flight of stairs in the crook of the L. A wood frame deck with railing is attached to the west elevation.

Significance Narrative: This house was built in 1952 and has some things in common with a World War II Era Cottage, such as the shallow-pitched roof and boxy shape. Otherwise it is a nondescript vernacular structure with no distinctive characteristics. Obvious alterations include the filling in of the original garage entry and the replacement of all windows with vinyl sash units. This house is not eligible for listing in the National Register of Historic Places.

Figure F.7. Andrade House, 6633 Lake Washington Blvd. SE, north and west elevations, view to the southeast.

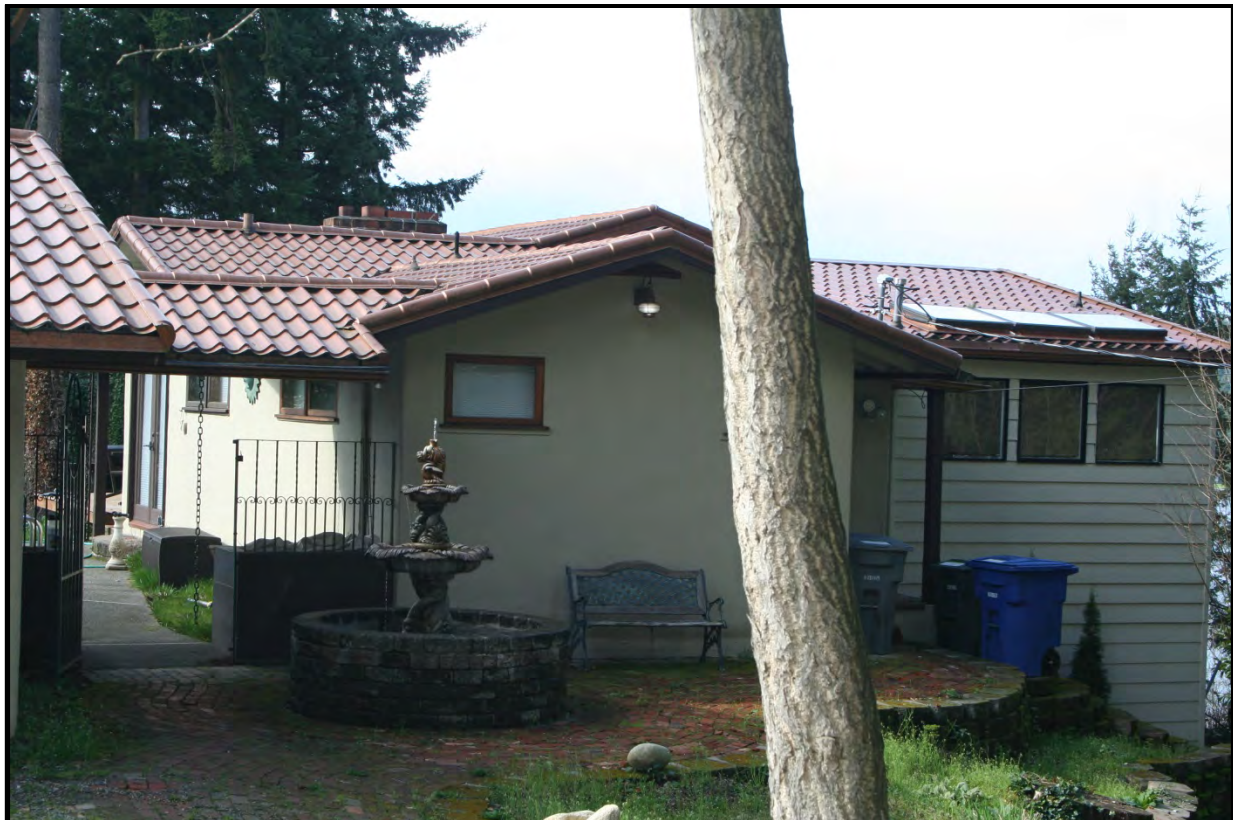
Physical Description: This property consists of two buildings, a house and a smaller office/shop. The rectangular shop is gabled, with a Spanish Mission tile roof. A small cupola, also with tile roof, is situated at the roof center crest. The walls are clad with stucco. Windows are wood sash. The house has an irregular plan, with several gabled wings. The roof is the same Spanish Mission tile; the eaves are similar as well. The house is clad with stucco except for a newer gabled addition attached to the north side of the house. The siding here is wood clapboard. The windows are wood sash sliding and fixed units.

Significance Narrative: This residence and shop/office is distinguished by its Spanish Mission tile roof and stucco cladding. Built in 1952, it has some Ranch Style elements, mostly in the shallow-pitched roof. Otherwise it is a fairly nondescript building that has been modified, primarily the addition of the gabled extension to the north, with different siding. Although it is a close call, this house does not qualify for listing in the National Register of Historic Places.

Figure F.8. Garcia House, 5449 Lake Washington Blvd. SE, east elevation, view to the west.
