**WSDOT NPDES Municipal Stormwater Permit
Monitoring Status Report
Water Year 2021**

October 2022

Stormwater Monitoring and Research Program
Environmental Services Office
Washington State Department of Transportation

Stormwater Monitoring Report

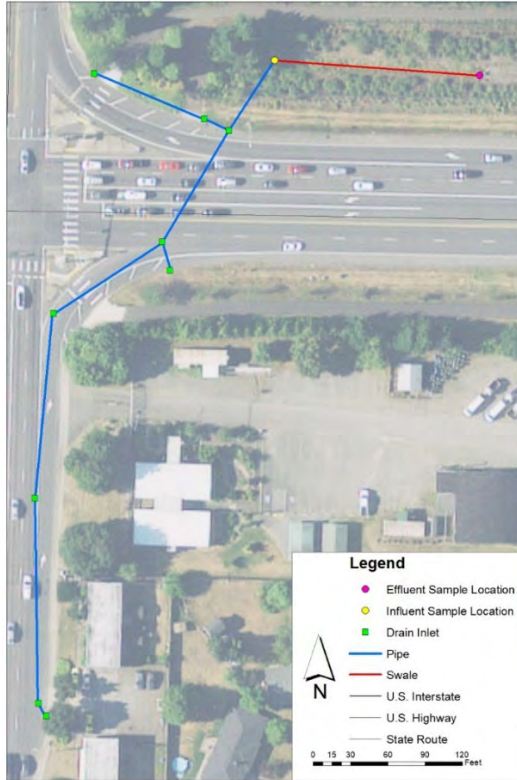
Figure 2. Vancouver biofiltration swale monitoring site and associated drainage features

The Vancouver biofiltration swale is located at milepost 7.00 on State Route (SR) 500 and treats stormwater from the intersection of SR 500 and SR 503. The biofiltration swale was built for Clark County in 1999 and came under WSDOT ownership in 2005 when Padden Park Way became SR 500.

The biofiltration swale is located northeast of the intersection and receives runoff from a 1-acre drainage area. The stormwater conveyance system is highlighted in Figure 2. The drainage area was ground-checked through multiple site observations during storm events, including heavy rain events. The biofiltration swale does not receive water from local roads or any non-WSDOT property.

Construction and installation of monitoring equipment took place during water year 21. Supply chain and other covid-19 related delays pushed the sample start date to October 28, 2021.

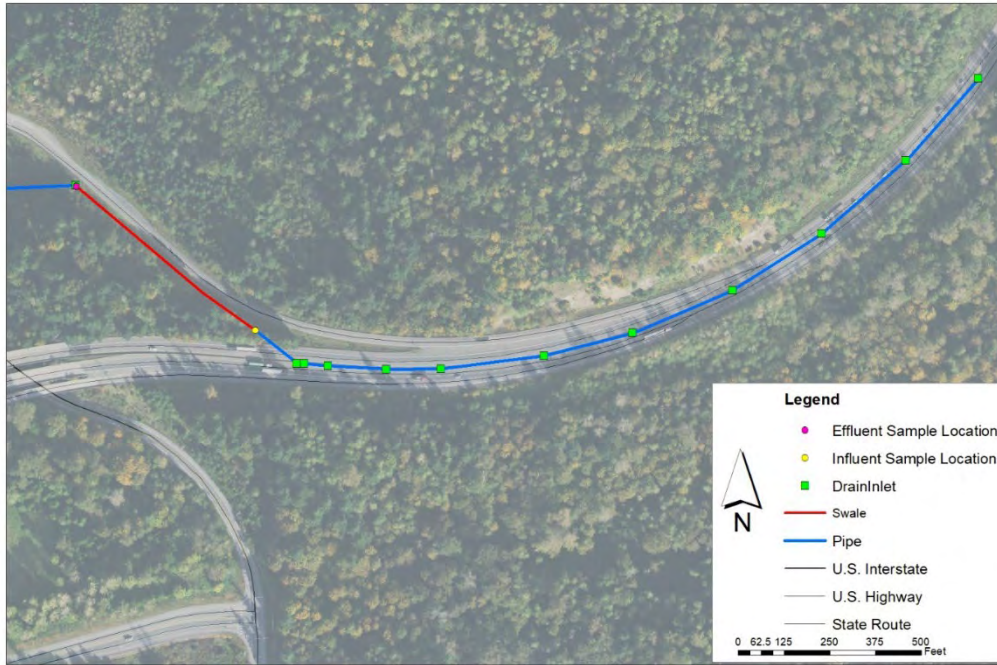
Figure 4. Mirrormont biofiltration swale monitoring site and associated drainage features

The Mirrormont biofiltration swale is located at milepost 20.48 on SR 18 and treats stormwater from SR 18 mainline lanes. The Mirrormont biofiltration swale was built to 1995 HRM standards in 1999.

The biofiltration swale is located on an offramp north of mainline SR 18 and receives runoff from a 3.5-acre impervious drainage area. The stormwater conveyance system is highlighted in Figure 3. The drainage area was ground-checked through multiple site observations during storm events, including heavy rain events. The biofiltration swale does not receive water from local roads or any non-WSDOT property.

Construction and installation of monitoring equipment took place during water year 21. Supply chain and other covid-19 related delays pushed the sample start date to October 28, 2021.

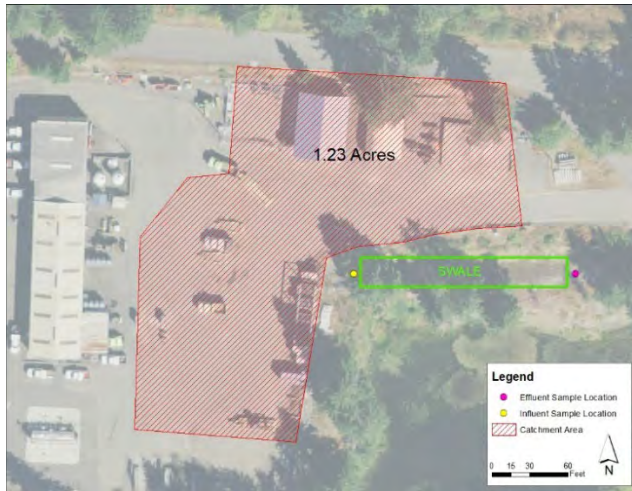
Figure 7. Mottman CABS monitoring site and associated drainage area

The Western Washington CABs is located at the Mottman Maintenance Facility (Mottman) at 2120 R.W. Johnson Blvd. SW in Tumwater. The Mottman CABs is a retrofit of an existing swale located at the facility.

The Mottman CABS is located east of the site’s primary maintenance activities and receives runoff from a 1.23-acre drainage area highlighted in Figure 5. The delineated drainage area was ground-checked through multiple site observations during storm events, including heavy rain events. The CABS does not receive all the Mottman Maintenance Facility’s stormwater runoff, which is directed to multiple points. This study only addresses the Mottman pollutants generated in the immediate drainage area.

The previous swale at Mottman was removed and new soil, compost, and seed was installed. The effluent pipe that drains the swale to the nearby pond was lowered, this brought the swale into current HRM guidance for slope specifications.

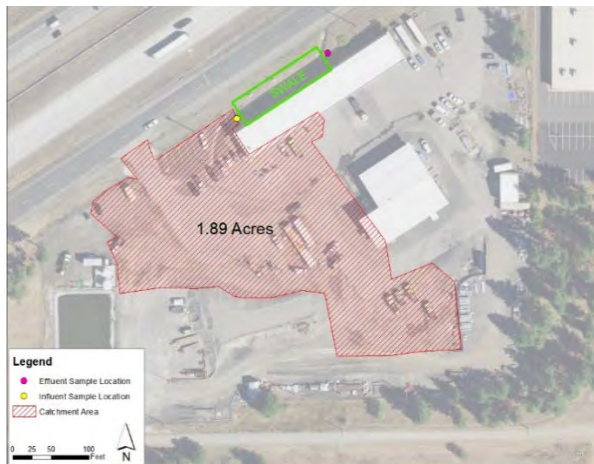
Figure 9. Geiger CABS monitoring site and associated drainage area

The Eastern Washington CABS is located at the Geiger Maintenance Facility near the Spokane International Airport at 7211 West Westbow Boulevard, west of the City of Spokane. The Geiger CABS is a retrofit of an existing swale with a siltation basin installed prior to the swale influent.

Figure 6 shows the 1.18-acre drainage area. The delineated drainage area was ground-checked through multiple site observations during storm events, including heavy rain events. The CABS does not receive all the Geiger Maintenance Facility's stormwater runoff, which is directed to multiple points. This study only addresses the pollutants generated in the immediate drainage area.

Siltation basin was designed by WSDOT and installed. Swale was reconstructed to compensate for the loss of length because of the basin. New soil and seed were added to the swale. Compost will be added, and vegetation establishment will take place over water year 22.
